A new lightweight support for the restoration and presentation of a large Roman mosaic

This paper presents a new technique employed in the construction of a lightweight backing for the Roman floor mosaic XIII.8 from Emona (Ljubljana, Slovenia). The rather large mosaic did not remain in situ but was instead lifted in 1997 before being restored and reassembled during a long and demanding conservation process between 2013 and 2014. Due to the size of the mosaic and subsequent demands associated with its presentation, as well as the need for easy handling when carrying and assembling the restored fragments, a necessity arose to develop a lightweight, compatible and easily removable support. Hence with an investigation of mechanical properties of lightweight mortars based on natural hydraulic lime was carried out. A low mortar density was obtained via the use of a lightweight aggregate composed of recycled glass beads. Conservation–restoration processes included documentation, cleaning, application of the new support, retouching and reassembly of the mosaic fragments.

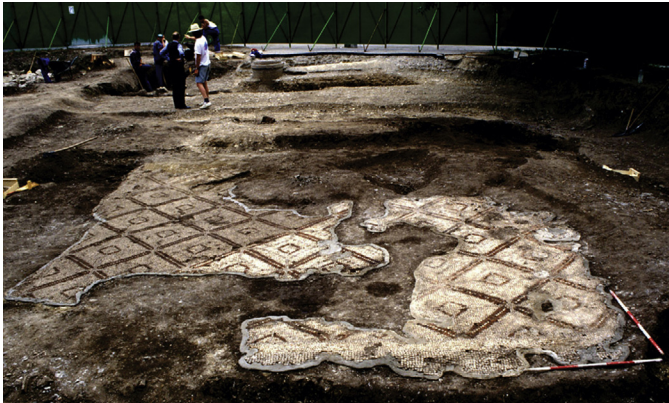
Fig. 1. The mosaic after excavation in 1997.

The remains of the Emona mosaic XIII.8 (Fig. 1; found in insula XIII, room 8) were first discovered in the eastern part of Emona between 1909 and 1912, during an excavation campaign led by Schmid and subsequently reburied [10].

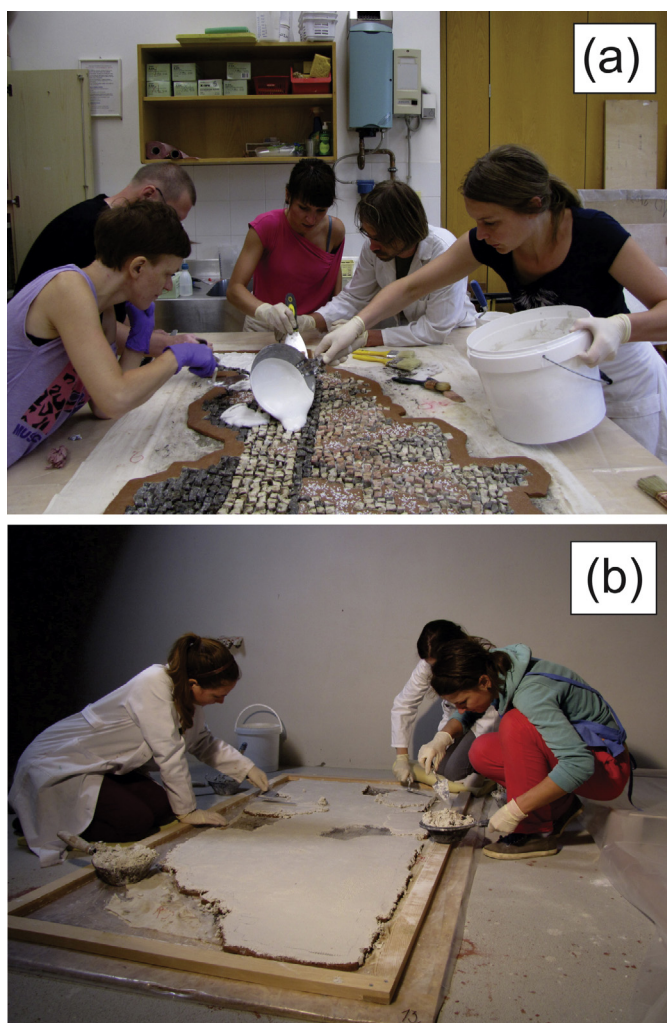
Fig. 4. Application of the lightweight mortar layer to the mosaic backing. (a) Application of bedding mortar to the mosaic fragments with edges temporarily protected with plasticine. (b) Application of the second lightweight mortar layer.

Before the selected mortar mixture was applied to the mosaic fragments, the fragment edges were edged with plasticine, thereby temporarily ensuring that the mortar could not reach beyond the mosaic edge (Fig. 4a). Due to the lack of information on how the original tesserae had been placed into the mortar bedding layer or filled with a grout when it had been created, it was decided that the current state of the original tesserae marked by the ravages of time be shown and preserved. Thus, the back surface of the mosaic fragments was covered with calcite sand (grain size 0.5 to 1 mm), which filled the spaces between the tesserae and thus enabled their tops to be positioned 1 mm above the bedding mortar and also prevent the mortar to spill over the facing of the tesserae. Sand, which was later removed during the cleaning of the facing, allowed us to easily demonstrate the state of the edges of each individual tesserae.

The mosaic back, having been wetted, was then filled in with the layer of bedding mortar composed of calcite sand, natural hydraulic lime, and the lightweight filler Microsil in a 1:1:1 mass ratio. The four sides of mosaic tesserae were enclosed by a depth of a bedding layer reaching up to three quarters of their height, with the mortar applied using brushes. The mosaic was then shaken so that

the mortar would settle and reach its temporary support. The first approximately 1 cm thick layer of lightweight mortar was applied using trowels to achieve a flat and smooth surface, pressing hard onto the layer beneath to prevent the formation of air pockets. This layer of lightweight mortar was reinforced with a glass fibre mesh, alkali-resistant due to its styrene-butadiene rubber coat. The second layer of lightweight mortar was applied in a thickness of approximately 1 cm as well (Fig. 4b). Its addition evened the back surfaces of all the mosaic fragments, also levelling the height of all the fragments with the resulting composite approximately 2.5 cm high. The mosaic fragments treated were then left for three weeks for the mortar to set and harden, with the mosaic surface wetted daily during the first two weeks to prevent crack formation in case the mortar dried too rapidly.

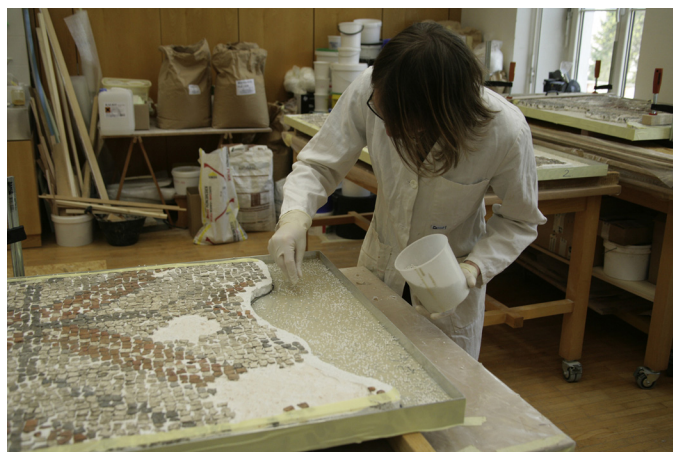
Fig. 6. Fragment embedded into a new support and the process of gluing the beads of recycled glass to the panel for the application of decorative render to fill the lacunae.

Areas where the mosaic was completely destroyed, located between the mosaic edge and the edge of the aluminium honeycomb panel, were filled with decorative render in two layers (Fig. 7). For the bottom layer the lightweight mortar was used up to a depth of 0.5 cm below the mosaic surface, while the second layer of mortar was then applied in the form of a mixture of calcite sand and natural hydraulic lime in a 2:1 ratio, in order to obtain the desired mortar texture, to a depth of 1 mm below the mosaic surface.

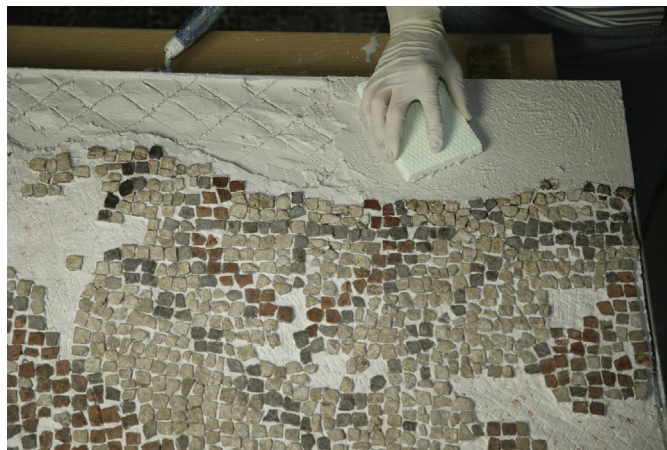
Fig. 7. Application of a decorative layer.

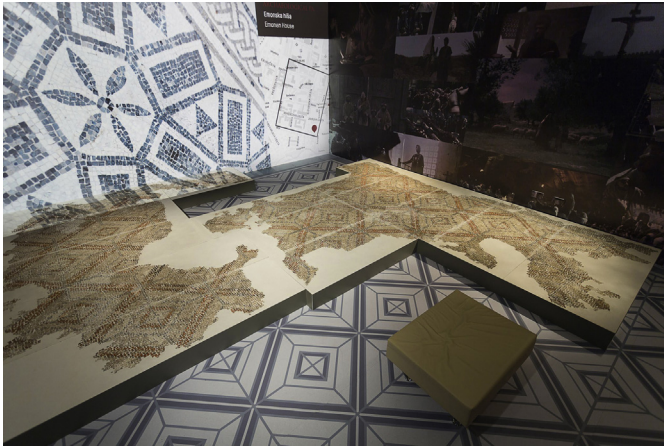
Fig. 8. Presentation of the restored mosaic at the exhibition *Emona: a City of the Empire*.

All 14 mosaic fragments were then ready to be reassembled and now make a coherent whole. The mosaic was moved to the exhibition hall and assembled for the temporary exhibition in the City Museum of Ljubljana. The mosaic panels were placed on additional supports, 30 cm from floor level to enable better visibility (Fig. 8). On the floor there was also a life-size graphic reconstruction of the mosaic in black and white. Visitors were thus able to conceive the original size of the mosaic and the hall in which it stood in Antiquity.
