**PERIODICO di MINERALOGIA**  
*established in 1930*

## Hydraulic mortar and problems related to the suitability for restoration

This paper describes the study for the evaluation of an hydraulic mortar for restoration, specifically for masonry plastering. The formulation was based on a mix of NHL added with metakaolin, and was designed for applications on soft and porous calcareous stones. Determinations of some parameters on the fresh mortar were carried out and physical-mechanical characterisation of the hardened product was provided. Durability with respect to the action of the soluble salts and to the behaviour of the stone/mortar system were also concerned, by testing the mortar on composite specimens (mortar + stone).

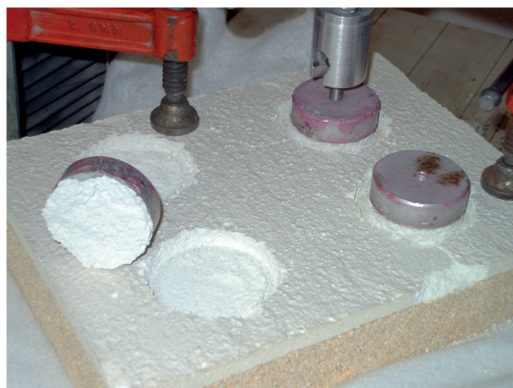
Figure 1. Adhesive strength test on the stone/mortar composite specimen.

- adhesive strength test (UNI EN 1015-12) (Figure 1).

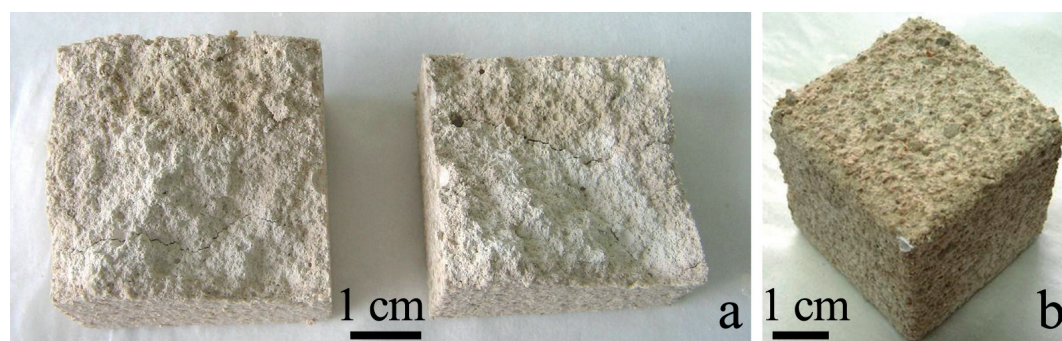
Figure 9. Broken sample with the evidence of internal fissures (a); sample after 15 cycles, showing material loss from the surface by granular disintegration (b).

part of the broken samples (Figure 9a). Damage by salts crystallization occurs when the pressure developed by the salt growth exceeds the tensile strength of the material. An adverse role with respect to the mortar durability could had been played by microcracks occurring during the shrinkage, that were observed microscopically. Shrinkage microcracking was found to strongly decrease the flexural strength of mortars (Velosa et al., 2009). Their random presence could explain why certain samples broke and other are able to resist to the salt action.
