CULTURE, MEDIA & FILM | RESEARCH ARTICLE

Interdisciplinary approaches to understanding and preserving mudbrick architecture in regional and diachronic contexts

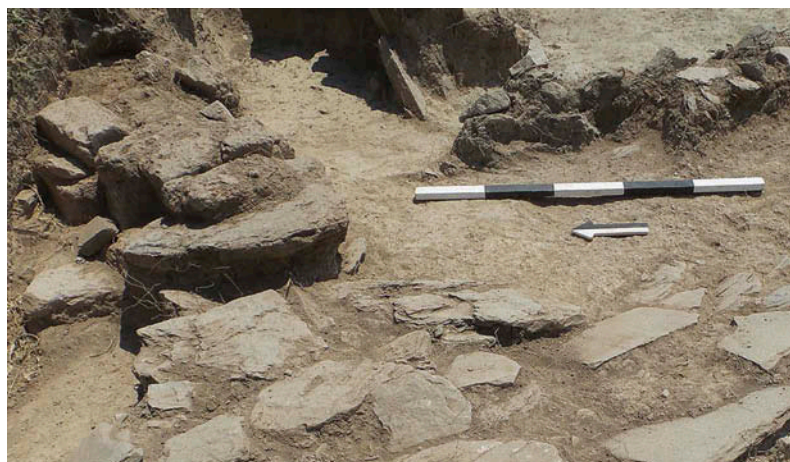
Figure 2. Two courses of mudbrick preserved *in situ* on top of stone socle recovered from Kaymakçı (KAP 97.545).

While research at Sardis dates to the 1970s, investigations at the Middle to Late Bronze Age site of Kaymakçı (see Figure 1) began in 2012. Three years of excavation on site under the KAP provides critical information about the extent and nature of local mudbrick construction. Excavation and analysis of recovered material reveal evidence of older earthen architecture traditions dating to the second millennium BCE. Despite poor preservation characterizing most architectural evidence of mudbrick, increasing diversification of methods of investigation in recent years (e.g. Love, 2017) enables collection of new, meaningful information regarding production technology and choice. Archaeological data indicate that stone foundations and mudbrick superstructures define normative architectural traditions. While there is an extensive mudbrick corpus, there is limited archaeological evidence for *in situ* construction. The best-preserved evidence consists of two courses of mudbrick superstructure sheltered from postdepositional degradation and weathering by a fortification wall (Figure 2).

Most, but not all, mudbrick finds show evidence of surface accretions developed during weathering from air and wind exposure (see Figure 2). Many exhibit uniform calcium (Ca)-rich surface coatings ranging between 0.001 and 0.005 m in thickness, similar to those found on ceramic, stone, and bone artifacts excavated from the site. The presence of Ca-rich surface accretions confirms that, while the site is situated on/or near bedrock, the clay matrix of Kaymakçı soils retains moisture for extended periods. Exposure to substantial wind and water following abandonment is most likely responsible for weathering on mudbrick structures at Kaymakçı. This is analogous to observed damages associated with derelict modern structures preserved in the area today.

coatings, suggesting a frequent maintenance cycle. This differs from ancient mudbricks recovered from Kaymakçı, which incorporate a finer range of aggregate, lower percentage of organic temper, greater variance in standard brick size, and high-fire sintering (see Table 1 and Figure 2).

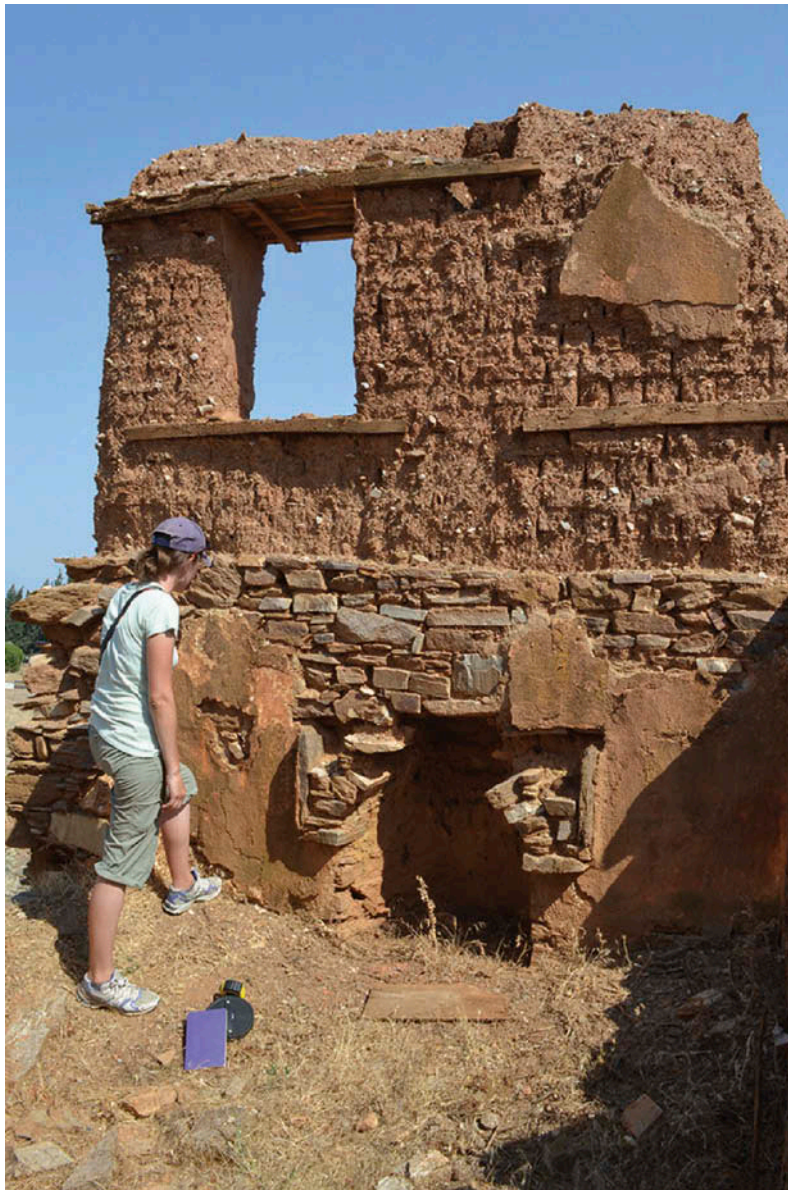
Figure 4. Typical vernacular mudbrick architecture where mudbrick is laid across stone foundations and wood beams provide support; please note areas where original plaster surfaces are preserved, Eski Haciveliler.

Most structures in Eski Haciveliler have stone foundations, some with extant mudbrick superstructures, wooden support beams, and, where preserved, layers of plaster covering the mudbrick (Figure 4). Both single- and two-story residences are found in the village, allowing in the latter case for the demarcation of storage, social, and family spaces. Found predominantly in the lower village, single-story dwellings are oriented toward courtyards and enclosed by walls that close the structures from the street (Luke & Cobb, 2013, p. 164). Through interviews with Haciveliler inhabitants, Luke and Cobb (2013, p. 164–6) highlight the importance of air movement, scent, and light in understanding how inhabitants organized and used their space. In addition, preserved sections of the buildings are extremely valuable documents recording the use of raw materials and manufacturing technologies used in construction through exposure of internal stratigraphic components. Therefore, mudbrick architecture from Eski Haciveliler and its orientation/interaction with the surrounding environment inform our understanding of building function, as well as degradation and post-abandonment processes at Kaymakçı, in spite of observed differences between ancient and contemporary bricks.

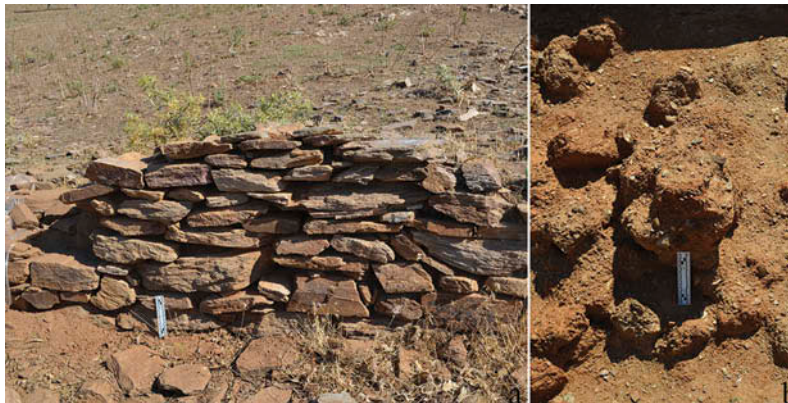
Figure 5. Eski Haciveliler conservation laboratory testing sites: (a) fieldstone masonry wall (south side) surrounding the schoolhouse perimeter and (b) mudbrick wall (west side) from the schoolhouse.

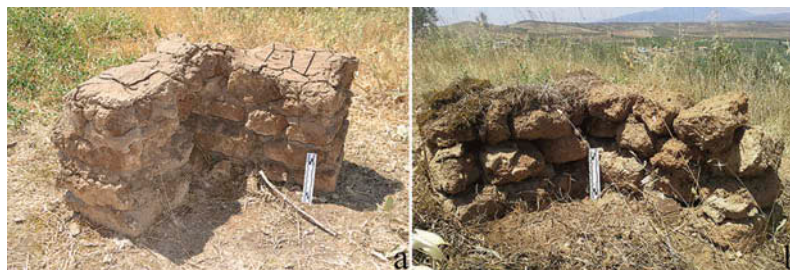
Figure 6. Tekelioğlu experimental L-shaped mudbrick wall: (a) just after construction in July 2013 (southeast side) and (b) 11 months later in June 2014 (southeast side).

Following the end of the 2013 field season, local colleagues continued to monitor the wall—wetting and photographing daily for an additional 2 weeks during the dry season. Thereafter, the wall was inspected on variable intervals (2–3 times per week, once per week, once every other week). Throughout this period, we were in regular discussion with our collaborators and made protocol adjustments based on their observations and knowledge of the environment. This dialogue was critical and resulted in the removal of the plastic covering 4 weeks after the date originally

scheduled due to unexpectedly high temperatures. The wall stabilized in November 2013 and remained in place with very little damage until March 2014, when grazing cattle caused significant damage. Following this incident, our local partners partially reconstructed the wall. Assessment in June 2014 (Figure 6(b)) indicated substantial color alteration and complete failure of all mud coatings applied between mudbrick courses, despite the high Ca-content of soils used. This is unsurprising as the mud coatings did not contain added binders (lime or cement) and reflects the need for semiannual (or more frequent) maintenance—critical information for preservation planning of the archaeological site. While we observed significant structural instability, most damage could be attributed to the April event when referencing our archive of digital documentation condition images.

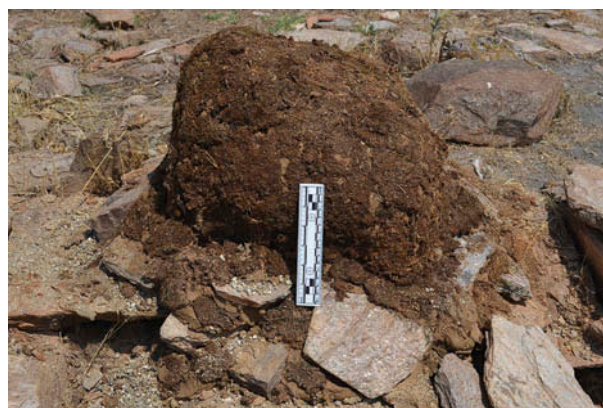
Figure 7. Soft vegetative cap applied to vertical and sloped surfaces of mudbrick (north side) at Eski Haciveliler.

Soft capping experiments at Eski Haciveliler tested vegetative capping materials applied to horizontal and vertical/near vertical mudbrick surfaces secured to a stone foundation. The soft vegetative cap incorporated the following layers placed on top of premoistened mudbricks in this order: mud coating, fine sand, geotextile, mud coating, gravel, mud coating, and vegetation (Figure 7). Following daily wetting and photo-documentation, the completed cap slowly dried for the following 15 days. This process of daily wetting and photographing continued at varying intervals until the end of the dry season. From mid-September 2013 to May 2014, the soft cap was watered and photographed weekly to document changes and characterize the cap's ability to protect the underlying mudbricks. Unsurprisingly, the Eski Haciveliler vegetative cap was unattractive in appearance and vertical/near vertical areas failed to achieve robust plant growth. According to images and verbal reports from collaborators, the vegetation component began to fail on the southern side as early as January 2014. This makes sense given the northerly winds associated with the site. In subsequent months, vegetation on the south side detached from most vertical surfaces. Furthermore, evidence of small mammal or insect damage appeared at the interface of the mudbrick with the stone-masonry substrate.

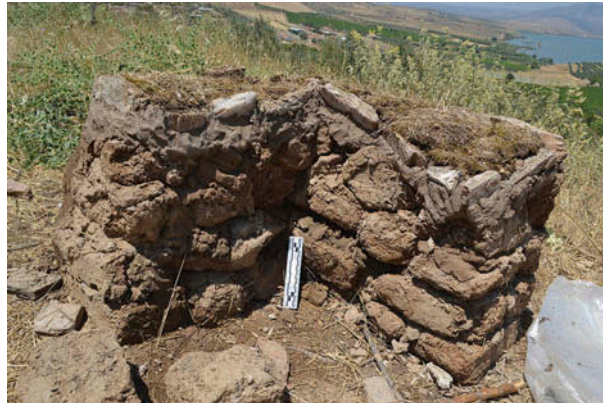
Figure 8. Soft vegetative cap applied Tekelioğlu experimental L-shaped mudbrick wall (top surface) directly after application.

In contrast to the Eski Haciveliler field trial, the soft cap system only protected the top horizontal surface of the experimental mudbrick wall in Tekelioğlu. Prior to installing the cap, thin sedimentary stones were set perpendicularly along the wall perimeter for protection using a lime–cement–soil–sand mortar mixture (5:1:2:6) using T4 soil. Following setting of the stone perimeter, we placed soft vegetative cap layers on top of the mud-coated, premoistened mudbricks using sand, geotextile, gravel, mud coating, gravel, dry soil, and vegetation (Figure 8). The completed cap was wetted, documented, and covered with a wet towel and plastic sheet to control drying. Local collaborators remoistened the towels daily for 15 days and at varying intervals thereafter, until the end of the dry season.
