WANDMALEREIEN IN KRYPTEN, GROTTEL, KATAKOMBEN

Zur Konservierung gefasster Oberflächen
in umweltgeschädigten Räumen

PASSIVE AND REMEDIAL APPROACHES TO SALT DAMAGE AND BIODETERIORATION OF WALL PAINTINGS AND MONUMENTS IN THE CRYPT OF THE GRAND MASTERS, ST JOHN'S CO-CATHEDRAL, VALLETTA

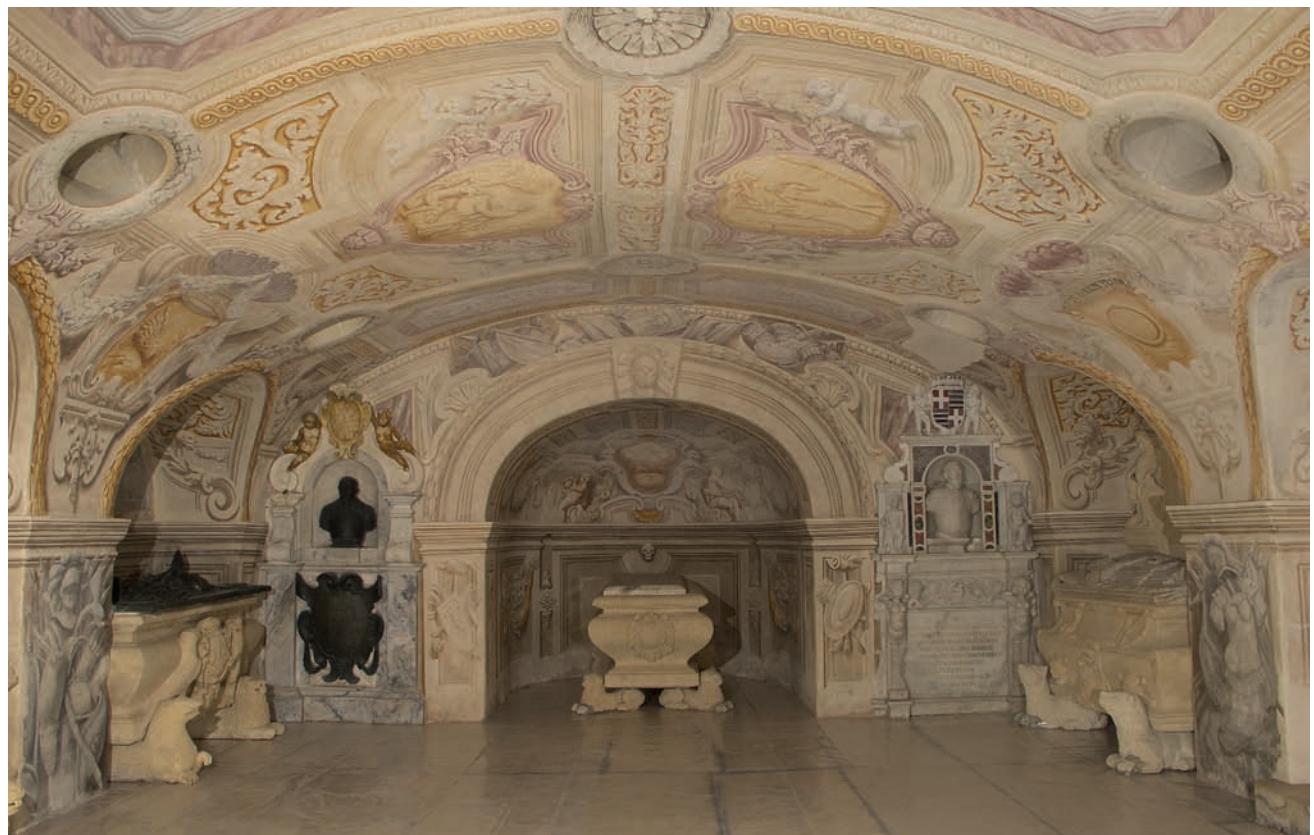
[1] The Crypt of the Grand Masters contains the tomb monuments of the first twelve Grand Masters and is decorated with a trompe l'oeil wall painting scheme (after conservation).

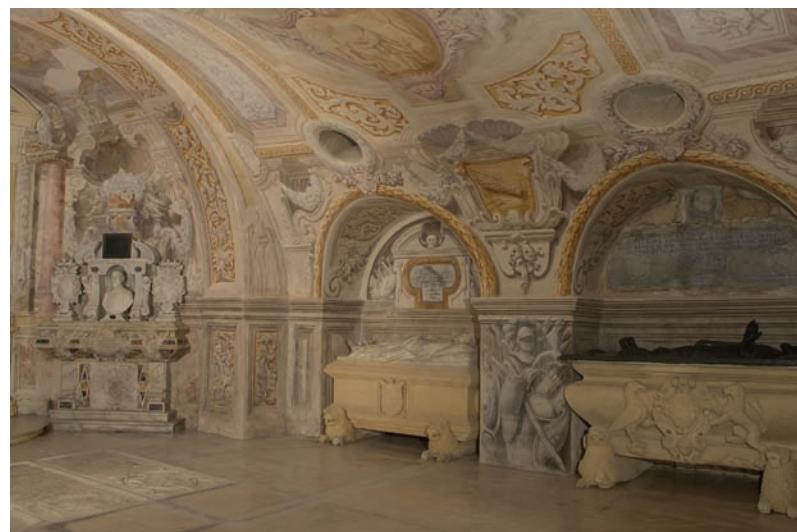
[4] Several of the tomb monuments are free-standing and constructed of globigerina limestone such as Parisot de la Valette (far right), while others, such as the monument of Martino Garzes, are made of marble and set into the wall (far left).

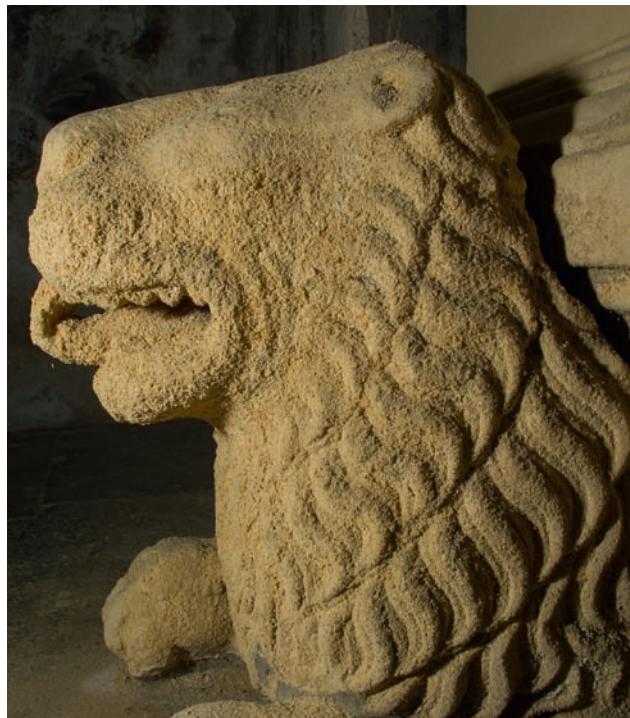
[7] Salt-related deterioration led to acute decohesion of the limestone monuments.

Globigerina limestone, the ubiquitous stone of Malta, was often selected for monuments since it is soft and easily carved. Globigerina is extremely heterogeneous,⁹ as reflected in the varying conditions of the monuments in the Crypt. Their deterioration also varies relative to their exposure to the single window in the Crypt: the sides facing the window exhibited more severe decohesion than the opposite sides.

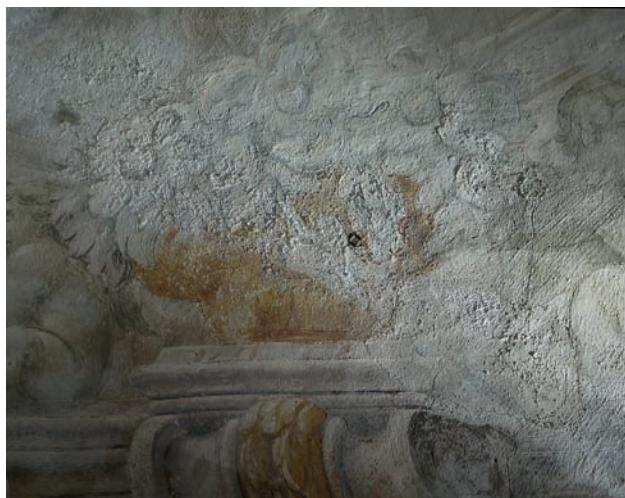
[9] Most of the paintings were covered in a heterogeneous white veil of salt efflorescences and biofilm. The salt activity disrupted the paint layer and the biofilm obscured much of the painting.

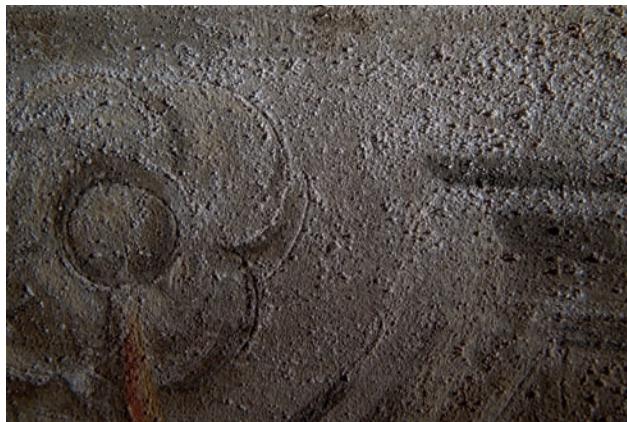
[15] Detail of salt efflorescences on painting, photograph taken during prevailing (baseline) environmental conditions (June 2003).

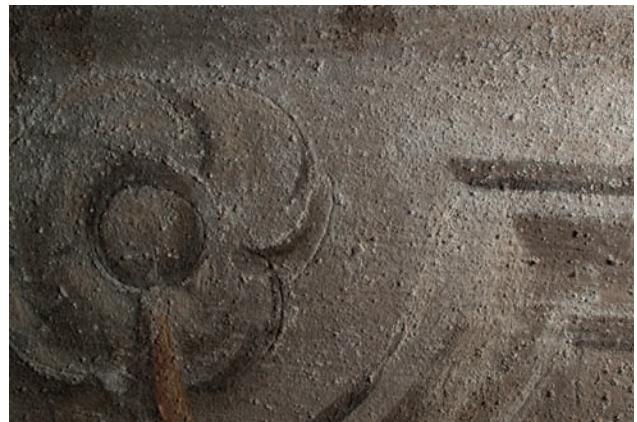
[16] Same detail as Fig. 15, photograph taken when external environments were excluded and the Crypt microclimate stabilised (June 2009).

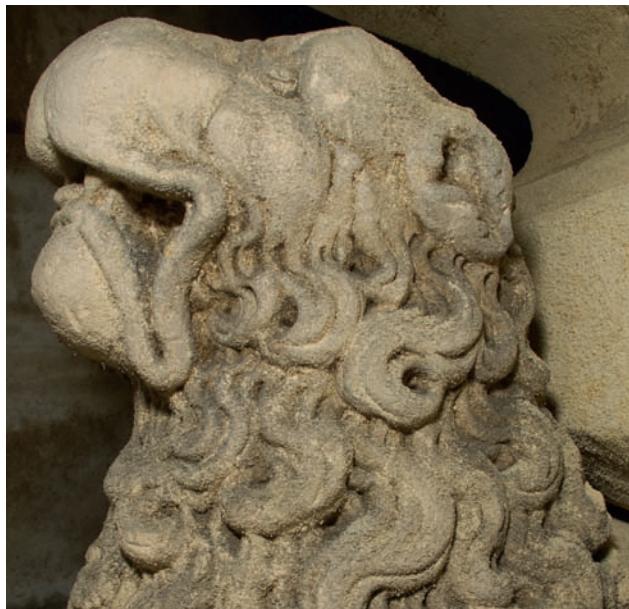
[19] Stone monument with acute decohesion and deposited dirt before treatment.
