**RESTORATION OF ANCIENT PORTUGUESE INTERIOR PLASTER  
COATINGS: CHARACTERIZATION AND DEVELOPMENT OF  
COMPATIBLE GYPSUM-BASED PRODUCTS**

Thesis approved in public session to obtain the PhD Degree in Civil Engineering

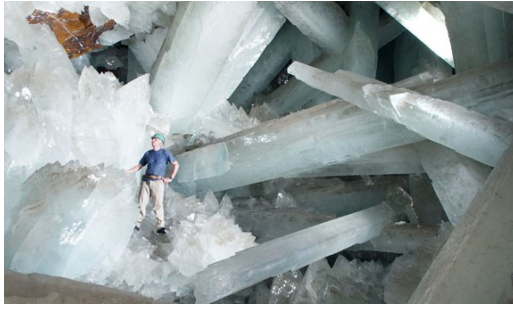
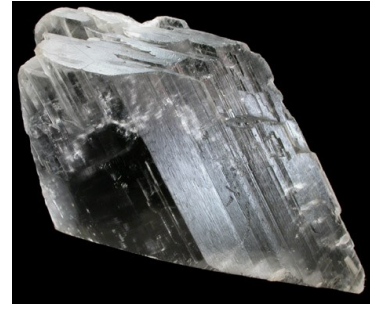
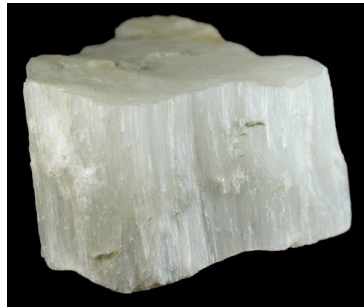
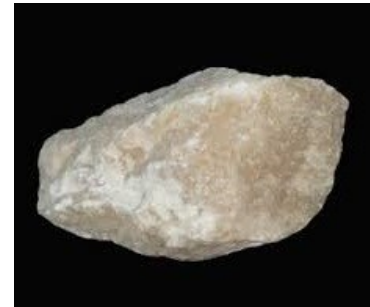
Figure 2.3 - Some gypsum natural varieties: (a) massive beams of selenite in Mexico's Cave of Crystals, deep below the Chihuahuan desert; (b) fragment of a giant crystal of selenite showing the transparent lamellar structure; (c) Satin spar (fibrous structure); (d) alabaster (marble-like gypsum, with massive, very fine crystalline structure) (<http://www.johnbetts-fineminerals.com/jhbnyc/mineralmuseum/> accessed 15 September 2015)

The most important rock textures of natural gypsum are selenite (made of large, lamellar, transparent crystals, whose name is due to Selena, the Greek goddess of the Moon, because of its moon-like glow), satin spar (with translucent fibrous crystals) and alabaster (with a compact, very fine crystalline structure used for statuary since antiquity and for interior decorations since the Middle Ages (Figure 2.3)). Anhydrite has also several varieties but these are of little importance compared with dihydrate (S.N.I.P. 1982; Karni & Karni 1995; Livingston et al. 1998; Wirsching 2005).

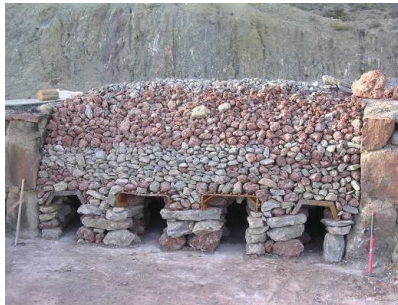
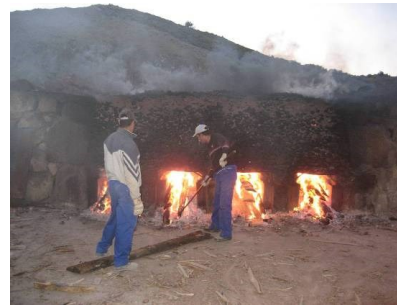
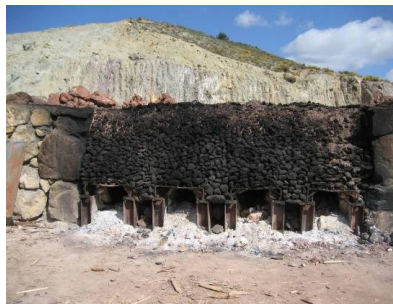
Figure 2.10 - Traditional intermittent gypsum kiln with four openings: (a) freshly prepared, ready to start calcination; (b) during the calcination process; (c) after calcination, ready to be dismantled (Sanz 2007).

*“(...) Procede-se ao carregamento d’estes fornos, começando por formar abobadas ou fornhalhas com as pedras mais grossas, e dispondo sobre estas as pedras cada vez menores, de modo que na parte superior da carga há apenas pó e fragmentos miúdos* (Figure 2.10 (a)). *Accendem-se as fornhalhas com lenha ou matto, eleva-se a temperatura a 120° ou 160°, e alimenta-se o fogo durante dez a quinze horas, conforme o estado atmosferico, a qualidade da pedra e o combustivel empregado* (Figure 2.10 (b)). *Considera-se completa a operação quando principiam a estar vermelhas as pedras das abobadas; (...) tapam-se todos os respiradouros e deixa-se arrefecer* (Figure 2.10 (c)).”

“The loading of these kilns is performed, starting by making domes or furnaces with coarser stones, and laying on these increasingly smaller stones, so that in the top of the load there is only dust and small fragments (Figure 2.10 (a)). The furnaces are lit with wood or bush, the temperature is raised to 120 °C or 160 °C, and the fire is fed for ten to fifteen hours, depending on the atmospheric state, the quality of the stone and the employed fuel

(Figure 2.9 (b)). The operation is considered complete when the stones of the vaults begin to be red; (...) all vents are covered up and the kiln is allowed to cool (Figure 2.10 (c)).”

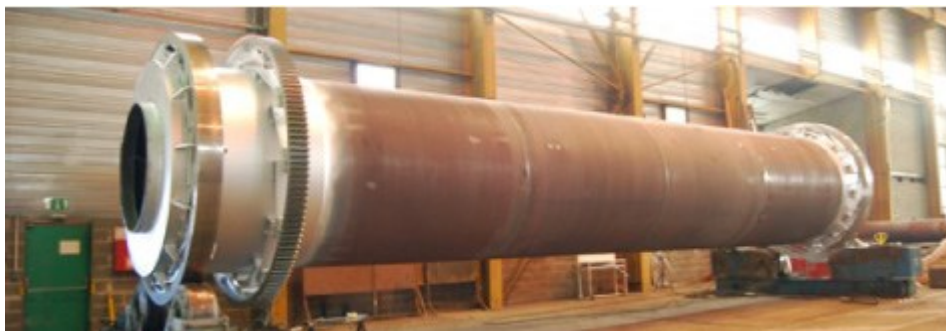
Figure 2.11 - Directly fired rotary kiln used to produce  $\beta$ -hemihydrate and multiphase plasters

Regarding current processes, developed and implemented mostly from the second half of the twentieth century, gypsum plasters are calcined in directly fired rotary kilns (Figure 2.11) or else in indirectly heated vertical or horizontal kettles. The last ones, also known as *Beau* kettles, work in batches and are more commonly used in France.

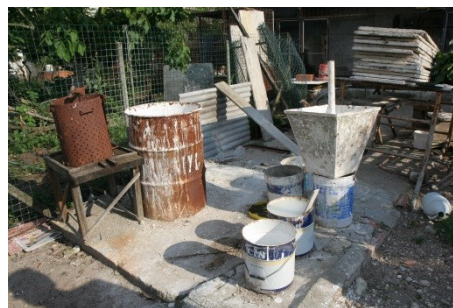
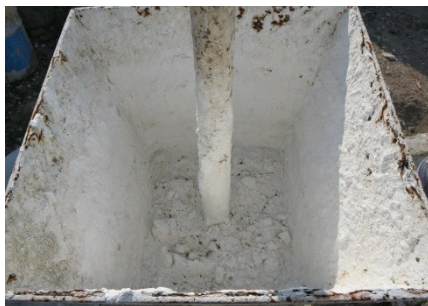
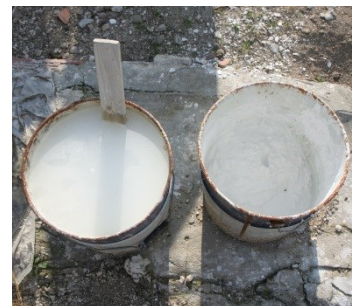
Figure 2.13 - Extinction of quicklime: (a) general view of the material; (b) sieving of slaked lime; (c) conservation of lime with excess water (left); putty (right)

Lime - Plasterer 1 buys quicklime (in stones) and slakes it with excess water (Figure 2.13):

- a) In a container of 200 litres he introduces 45 kg of quicklime and adds water until reaching about 160-170 litres of its capacity (Figure 2.13 (a));
- b) He lets it stay for, at least, one week, stirring once in a while;
- c) After that, he passes the slaked lime through a sieve (Figure 2.13 (b)) and transfers the lime putty obtained into buckets, covering it with water (Figure 2.13 (c), left);
- d) Before using it, he rejects the excess water and works with the putty (Figure 2.13 (c), right).

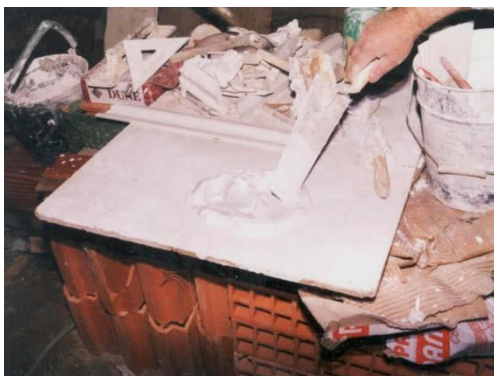
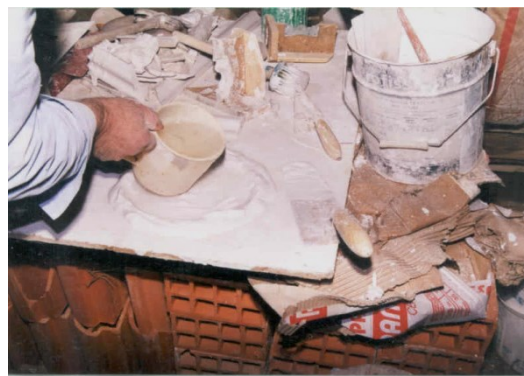
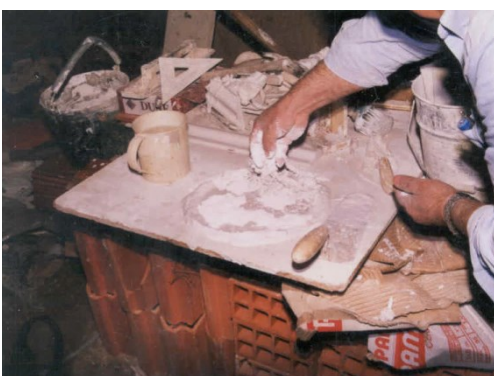
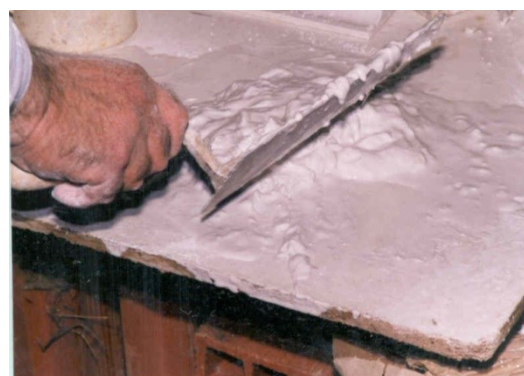
Figure 2.15 - Preparation of a lime-gypsum plaster paste: (a) opening of a clearing in the lime putty; (b) addition of water; (c) gypsum plaster sprinkled into the water; (d) mixture of materials (Margalha, s/d)

- a) The lime putty is placed in a clean, smooth surface and a clearing is open in its center (Figure 2.15 (a));
- b) The water is added at the intended content, and is deposited in the clearing (Figure 2.15 (b));
- c) The gypsum powder is sprinkled into the water (Figure 2.15 (c));
- d) The components are kneaded with a trowel until forming a homogeneous mass (Figure 2.15 (d)).

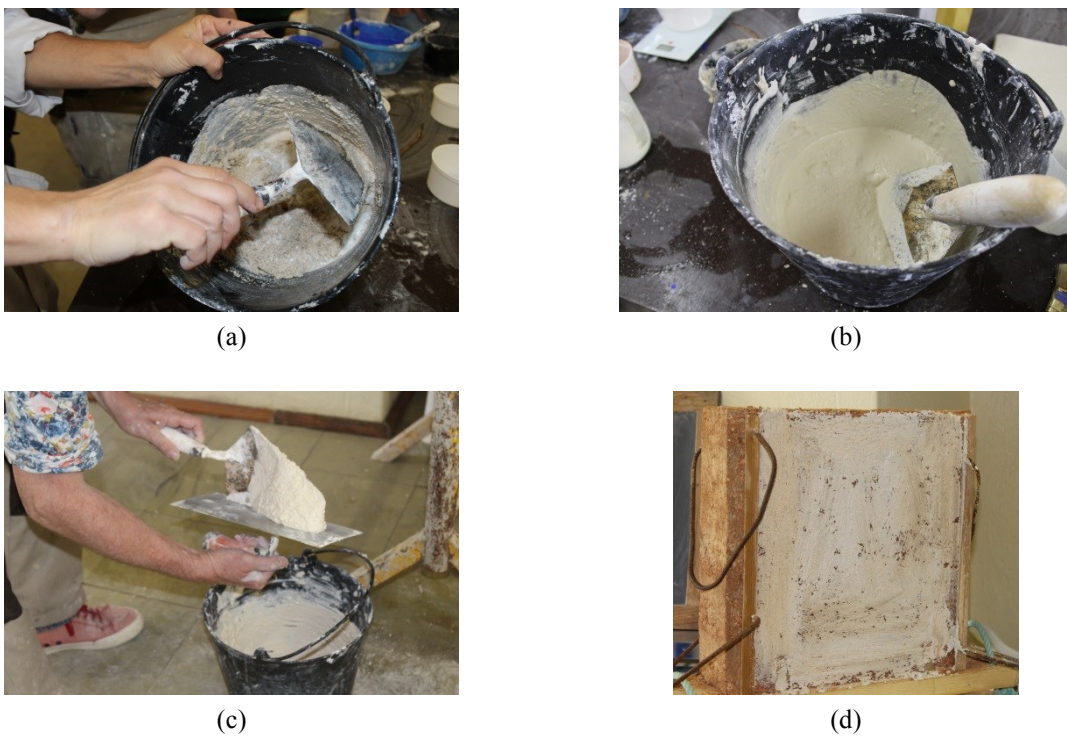
Figure 2.16 - First layer of a multi-coat plastering system: (a) mixing lime and sand; (b) and (c) lime mortar, ready to be applied; (d) rammed earth substrate after application of the first layer

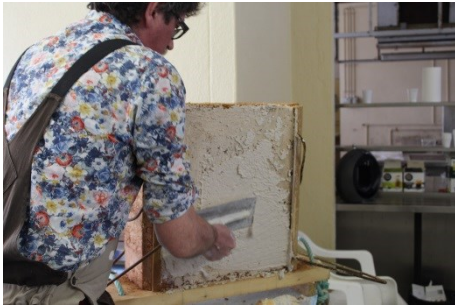
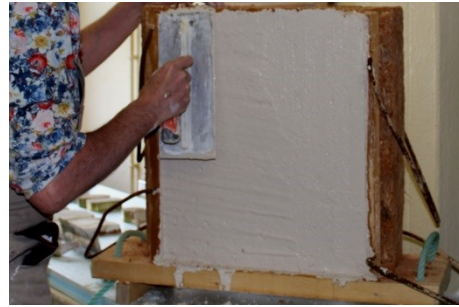
Figure 2.17 - Regularization layer (second coat): (a) application of the mortar with the border of the tool in upwards movements; (b) straightening of the surface

The regularization layer is applied over the first undercoat usually using a square trowel. The trowel contains the paste that is taken to the wall and pressed against it with the border of the tool in upwards movements (Figure 2.17 (a)). Afterwards, the coating needs planing with a ruler and again smoothing with the trowel which also functions as a float (Figure 2.17 (b)).

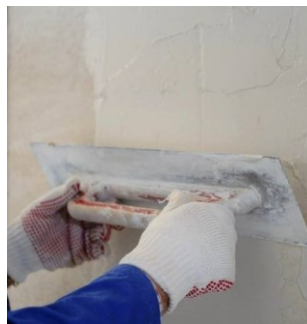
Figure 2.18 - Finishing layer: application of the lime-gypsum paste over the regularization layer

At the end, the finishing layer is usually applied as a very thin coat (2-3 mm). To promote adhesion it should also be pressed against the wall with the border of the trowel, in upwards movements (Figure 2.18). It can have several types of finishes that will be explained in the next section (*cf.* 2.3.4).

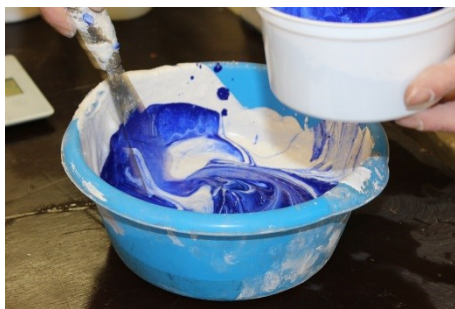
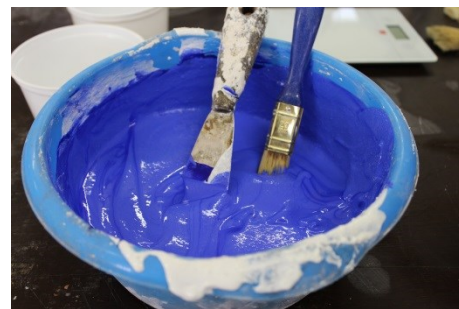
Figure 2.19 - Coloured plaster: (a) incorporation of the pigment in the paste; (b) homogeneous pigmented paste, ready to apply; (c) application of the coloured layer; (d) smoothing the surface; (e) final appearance; (f) pigmented paste being applied as paint

Traditionally coloured plaster surfaces can be obtained by: (i) *fresco* painting (a work that in general results very imperfect); (ii) diluting the pigment in the water to be used in the preparation of the mixture; (iii) incorporating it, also diluted, in the paste before application (Figure 2.19 (a) and (b)) (Veiga et al. 1995; Gárate-Rojas 1999).

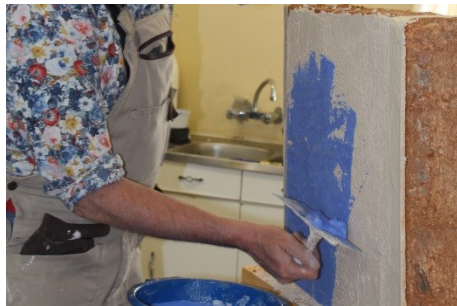
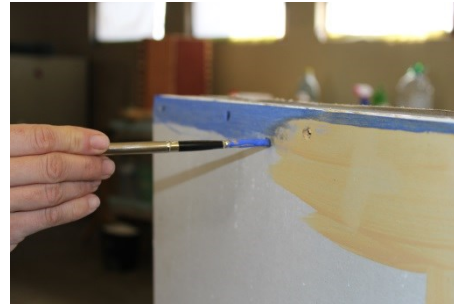
Figure 2.20 - Coloured plaster: (a) application of the coloured layer; (b) smoothing the surface; (c) final appearance; (d) pigmented paste being applied as paint

The pigmented paste can be applied in thin-layer to obtain a smooth surface (Figure 2.20 (a) to (c)) or with a brush, resulting in a lighter shade (Figure 2.20 (d)).

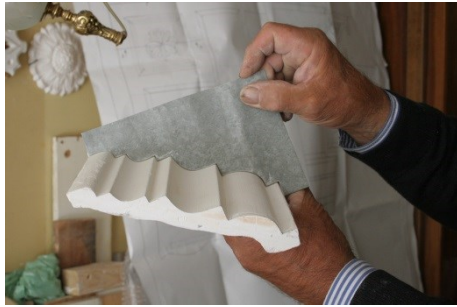
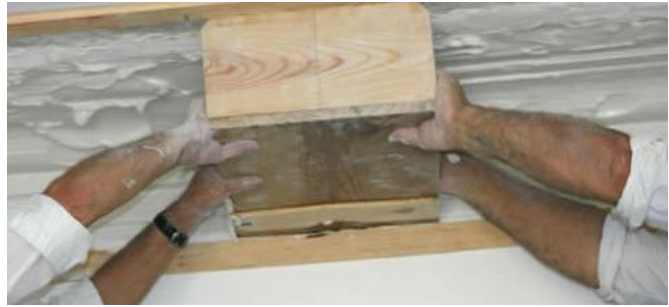
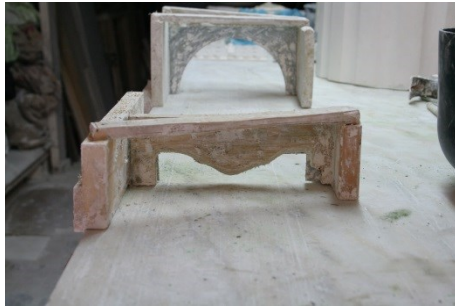
Figure 2.21 – Decorative elements with constant section: (a) zinc profile; (b) moulding on site; (c) moulds made of wooden base and zinc profile; (d) element moulded on bench

The frames, cornices or half-columns used to decorate the walls and ceilings of buildings often have straight or curved constant sections. They can therefore be moulded on site. The profile of the element is usually made of zinc plate (Figure 2.21 (a)) that is fixed to a wood base and runs on a wooden ruler, previously fixed to the wall (Figure 2.21 (b)). The plaster is placed between the surface of application and the mould. The mixes prepared for this purpose have commonly a higher proportion of gypsum than those used in thin-layer plaster finishings (Freire et al. 2010).

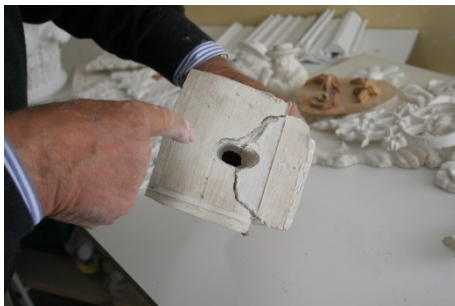
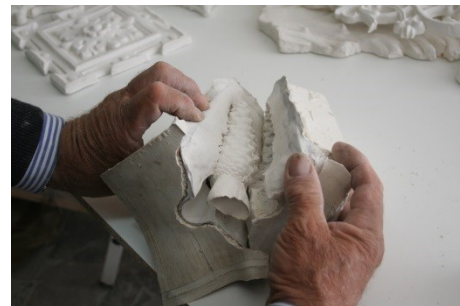
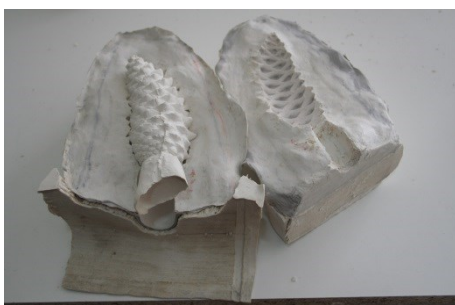
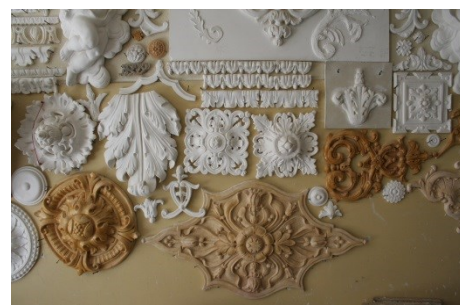
Figure 2.22 - Process of manufacture of precast decorative elements: (a) opening of the mould through which the gypsum plaster slurry is poured; (b) demoulding the piece; (c) complete view of the parts that constitute the mould with the corresponding piece inside; (d) view of some precast decorative elements

The decorative elements can also be precast. This technique is used essentially to manufacture pieces without constant section. It consists on filling the moulds with gypsum plaster slurry, prepared with fluid consistency to reproduce all the details (Figure 2.22).

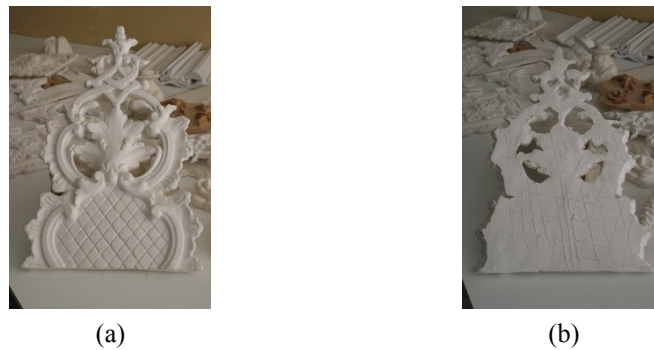
Figure 2.23 - Half ceiling precast ornament: (a) Front view; (b) back view, with grooves

On site the pre-manufactured elements are pasted to the surfaces with a mass consisting of a plaster mixture with more gypsum than lime (to harden faster). That mass is pressed hard against the base. To help improving adhesion, the back of the pieces have often grooves deliberately made (Figure 2.23). When the ornaments have higher weight and/or size, they cannot be applied using only the plaster “glue”; they also have to be fixed mechanically, by means of screws and nails (Malta da Silveira 2000).

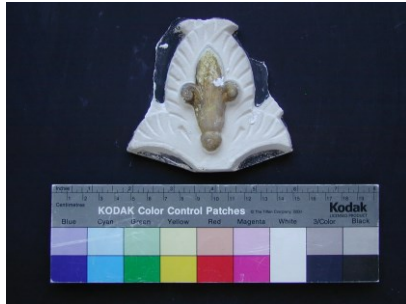
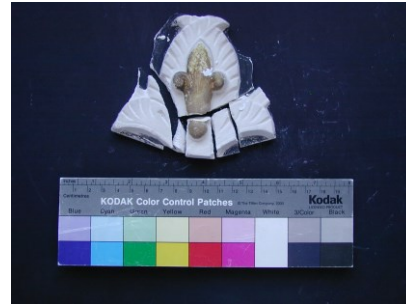
Figure 4.2 - Sample ISF1: (a) as it arrived on the lab; (b) divided in several fragments

Each specimen was then split into several fractions to be used in the various techniques (Figure 4.2).

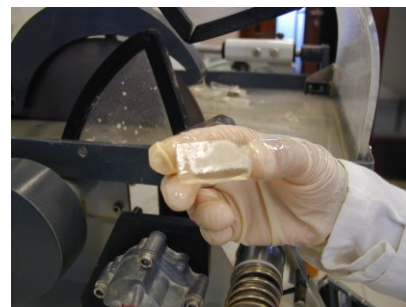
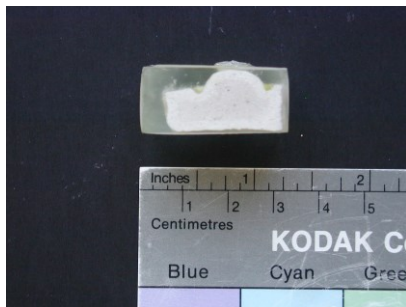
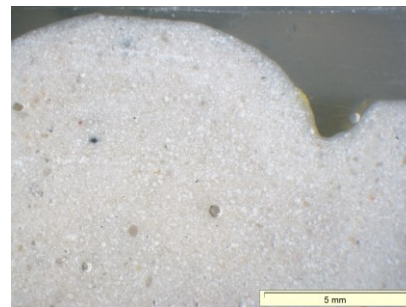
Figure 4.3 - Preparation of polished surfaces: (a) fragments of some samples impregnated with an epoxy resin; sample ISF2 after precision cut (b) and after being polished (c); (d) stereo-zoom image of the polished surface shown in (c)

In order to study the textural properties of the layers in the samples (stratigraphy) and to identify the mineralogy and morphology of the aggregates and possible pigments, fragments of the samples were prepared by impregnation under vacuum with an epoxy resin, followed by a precision cut and polishing procedures. The polished surfaces obtained were observed with the stereo-zoom microscope and images were recorded digitally (Figure 4.3 and Figure 4.4).

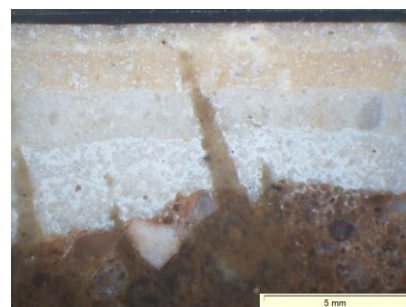
Figure 4.4 - Detail of a thin-layer plaster fragment (PE5) (a) after impregnation, cut and polishing operations; (b) stereo-zoom image of the polished surface shown in (a)

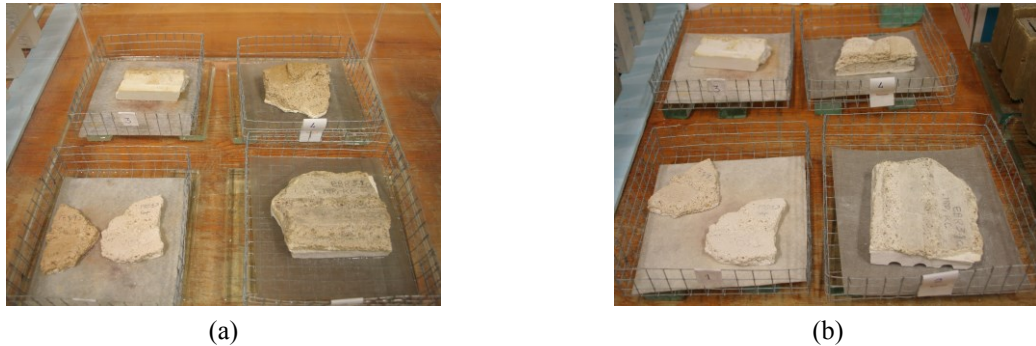
Figure 4.5 - Determination of the capillary water absorption in ancient samples using a contact technique: (a) samples in a vat where water reaches the bottom of the baskets (absorption procedure); (b) baskets placed in stands outside the vat (drying procedure)

The **water absorption** tests were performed using a capillary absorption by contact technique developed for irregular and/or friable samples (Veiga et al. 2004) (Figure 4.5 (a)).

After 24 h, the baskets with the samples are taken out of the vat and placed on two narrow stands in order to prevent contact with water or any other surface; the capillary absorption stops then and the drying process begins (Figure 4.5 (b)), proceeding until the test specimens achieve constant weight.

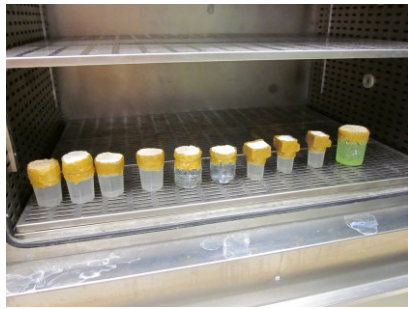
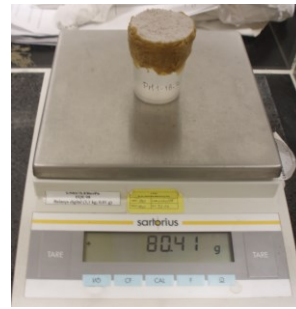
Figure 4.7 - Determination of the water vapour permeability: (a) ongoing test, in the climatic chamber; (b) weighing procedure

The **water vapour permeability** was determined using the method described in EN 1015-19:1998, adapted to the size of each sample (Figure 4.6). This method is based on the measurement of the water vapour flux through the sample due to the pressure differential between the internal (relative humidity approximately 100%) and the external surface conditions (relative humidity =  $50 \pm 5 \%$ ) at  $23 \pm 2 \text{ }^\circ\text{C}$ . The vapour flux is quantified by the weight variations of the test devices (Figure 4.7).

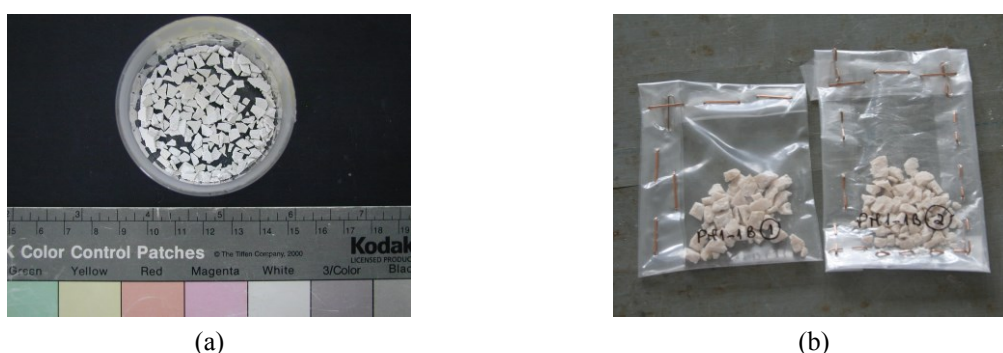
Figure 4.9 - Preparation of the test specimens for mercury intrusion porosimetry: (a) sample EG4 (thin-layer plaster) before drying; (b) sample PM1 ready to be tested

Each sample consisted of two specimens previously grinded to granular form and dried to constant mass at 40 °C. After that they were placed in individual bags identified with the name followed by the numeral "1" or "2" (bag 1 and bag 2, Figure 4.9) and maintained in a desiccator until testing.

At the beginning of the test procedure they were subjected to degasification for at least 30 minutes, at room temperature and using a vacuum of 50 or 60 mmHg. For the contact angle a standardized value of 140° was used in all determinations.

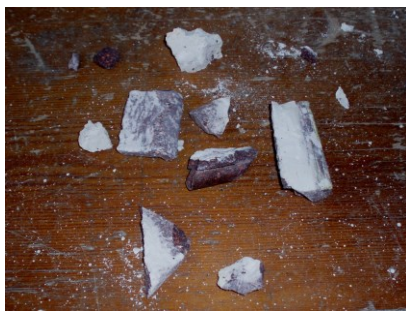
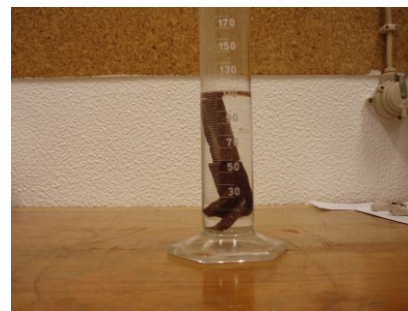
Figure 4.10 - Determination of the bulk density by the water displacement method

The *water displacement method* is based on the measurement of the water volume variation inside a graduated cylinder immediately after the insertion of previously weighed fragments of the sample. However, this method soon revealed to be inappropriate for most of the samples because it required the use of very small fragments and a very quick measurement of the water volume variation due to the high absorption of the materials under study. Finally, this can be considered a destructive method, as the referred fragments can no longer be used in other procedures.

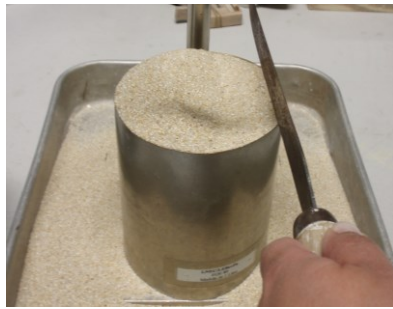
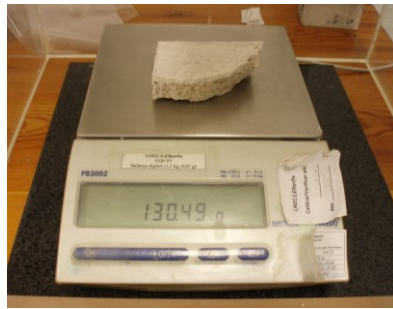
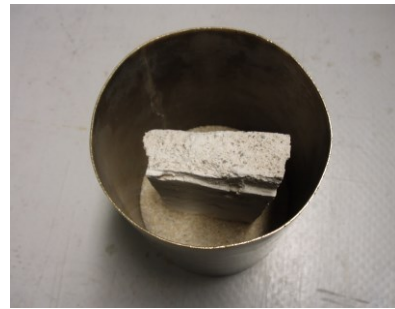
Figure 4.11 - Determination of the bulk density of the samples by the sand method: (a) and (b) bulk density of sand; (c) weighing of test specimen; (d) test specimen inside the vessel before the addition of sand

The *sand method* (Figure 4.11) is based on the determination of the volume of a test specimen previously dried at 40 °C and weighted, using the bulk density of calibrated sand (reference APAS 30 from the supplier AREIPOR, previously dried at 105 °C) according to the NP EN 1097-3:2002. The difference of weight between the metal measuring vessel with 1 litre capacity filled with “test specimen + sand” and only filled with sand is registered and the volume of the test specimen is calculated.

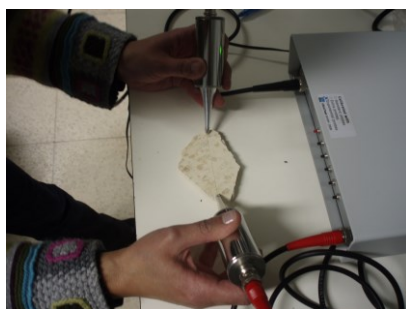
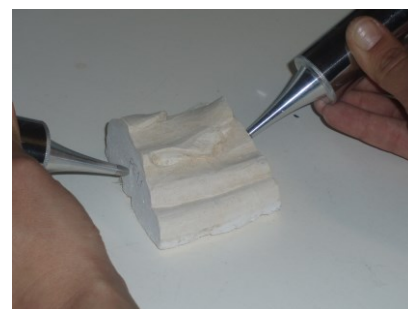
Figure 4.12 - Determination of the dynamic modulus of elasticity in ancient samples using ultrasound waves: (a) indirect method, probes in the same surface (superficial transmission); (b) direct method, probes in opposite surfaces (transmission through the material)

The **dynamic modulus of elasticity** was determined using the method of ultrasounds that is based on the measurement of the velocity of high frequency sound waves through the material under study, allowing the calculation of elastic parameters (NP EN 12504-4:2007). Special exponential probes with pointed ends were used to provide good and precisely located contact with the samples' surfaces.

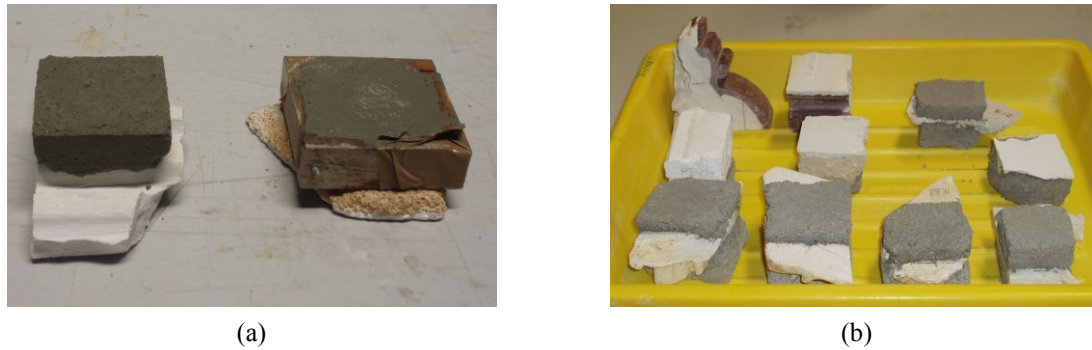
Figure 4.13 - Adaptation of ancient plaster samples to the compressive strength test device: (a) application of the shaping mortar; (b) samples ready to be tested

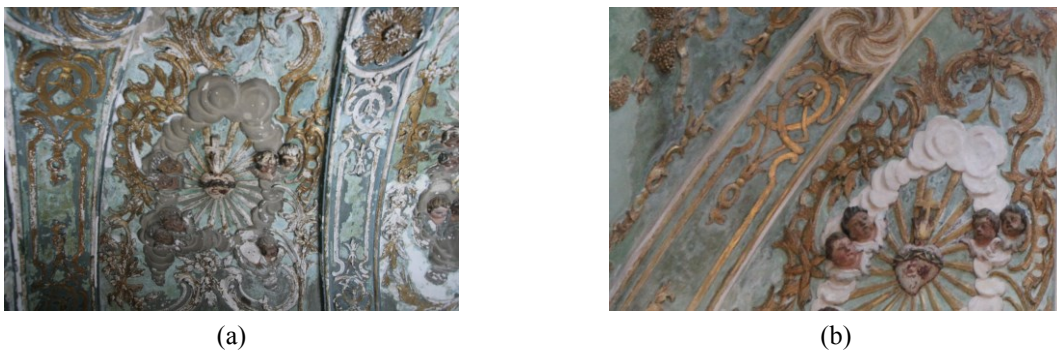
Figure 4.15 - Decorative plasters of the *Santissimo Sacramento*'s Chapel: (a) before restoration; (b) after restoration

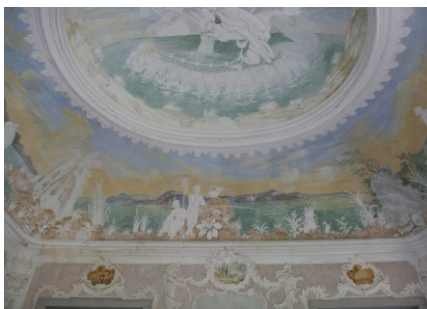
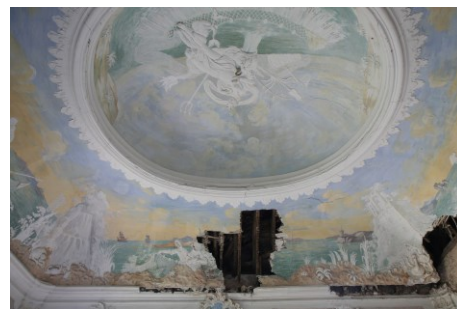
Figure 4.22 - Ceiling of *Casa da Pesca*'s interior room: (a) north side; (b) west side, in poor condition

The ceiling is decorated with very delicate and high quality stuccos representing scenes of fisheries, executed by Giovanni Grossi (Silva 2005). Even though it is the shelter of such a valuable work of art, the building is in a poor state of conservation and imminent ruin, endangering this important heritage (Figure 4.22).

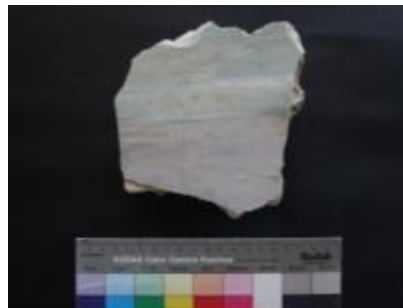
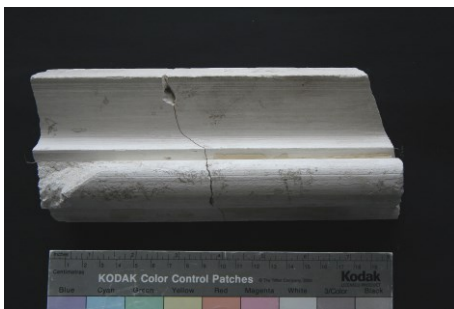
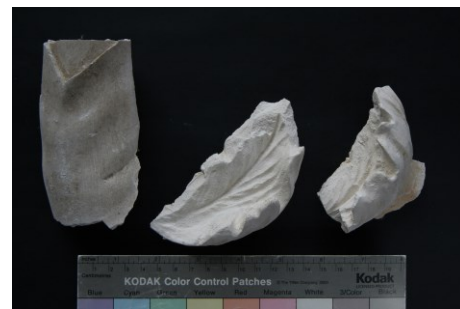
Figure 4.23 - Photographs of the analysed samples from *Casa da Pesca*: (a) one fragment from CP1; (b) two fragments from CP2; (c) CP3

Sample	Description
CP1	Six fragments from the <b>smooth surface</b> of the painted ceiling: three consisted of the final layer where the paint was applied and the other three had also a layer of mortar attached (Figure 4.23 (a)); The final plaster layer had fine particles size but relatively high thickness (7-12 mm), and was very stiff and compact.
CP2	Three fragments of a bulky <b>frieze moulded on a bench</b> (Figure 4.23(b)) with sisal fibres inside and a film of brown paper attached to the back; Moulded in two steps: first the core was made and then the finishing layer, with a very low thickness, seemingly having been applied consecutively; The fragments showed a pellicle of a painting (limewash type) that could be easily detached due to the dust it had behind (between the surface of the plaster and the paint), i.e. it was not applied originally.
CP3	Three fragments of <b>ornaments</b> of considerable volume representing vegetal related motifs (Figure 4.23(c)); They seem to have been <b>sculpted before application</b> : there are many similar ornaments on site even though all different, i.e. they have not been precast.

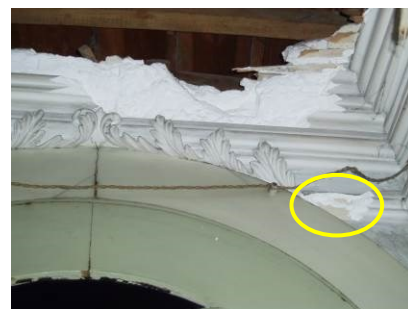
Figure 4.33 - *Restauração* Street building: (a) entrance hall; (b) detail of a collapsed ceiling (the yellow line indicates the place where sample ERR4 was collected)

The *Restauração* Str. building is located in *Porto's* city centre. It was built in the second half of the 19<sup>th</sup> century to be the dwelling house of a wealthy family (Figure 4.32). The stucco decoration is simple but denoting a good quality of execution. Some of the ceilings have already collapsed due to the poor condition of the building (Figure 4.33).

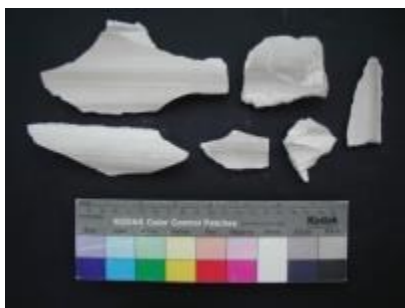
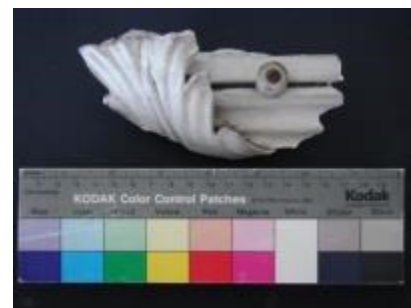
Figure 4.35 - Photographs of the analysed samples from *Restauração* Street building: (a) ERR3; (b) ERR4

Sample	Description
ERR3	Six fragments from the <b>final layer</b> of a cornice (Figure 4.35 (a)); The fragments had high thickness (10-15 mm), low density and were very friable; The frieze seems to have been moulded on site as its internal structure, consisting of a thick layer of mortar, was attached to the wall with iron rods (Figure 4.36).
ERR4	One <b>ornament</b> of considerable volume representing an acanthus leaf (Figure 4.35 (b)); It seems to have been <b>sculpted before application</b> as it belongs to a set of similar ornaments even though all different (Figure 4.32 (c)), meaning they have not been precast.

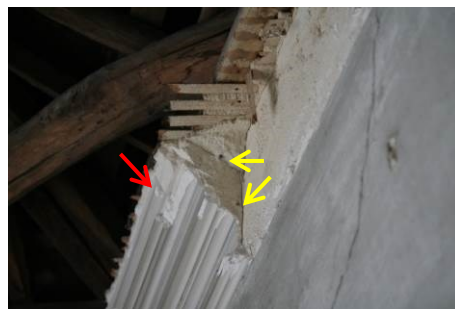
Figure 4.36 - Cross-section of the cornice from where sample ERR3 (red arrow) was taken, with iron rods (yellow arrows)

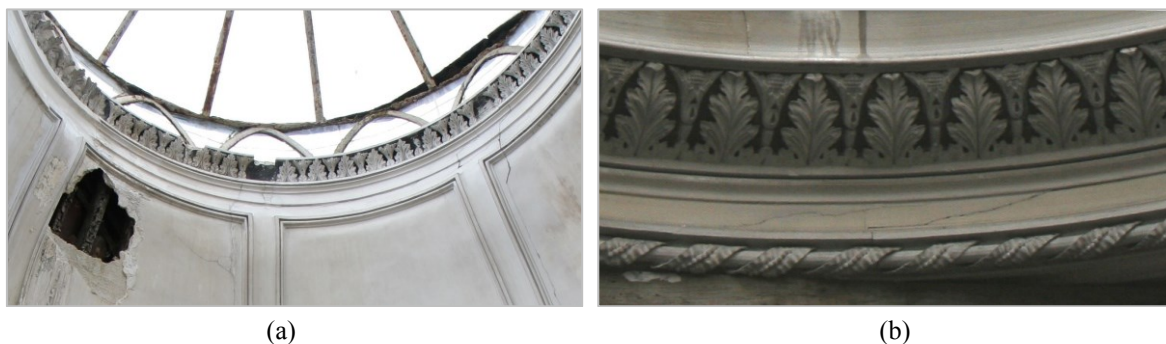
Figure 4.37 - Skylight framed by plaster decorations that have been precast: (a) top frame; (b) bottom frame

Similarly to what was observed in the case studies from the 18<sup>th</sup> century, the decorative elements corresponding to sample ERR4 are all different from each other (Figure 4.32 (c)) with no signs of having been made by an “industrial manufacture” process. However, there is a big skylight in the centre of the house, to illuminate the staircase, framed by plaster decorations that have been clearly precast (Figure 4.37).

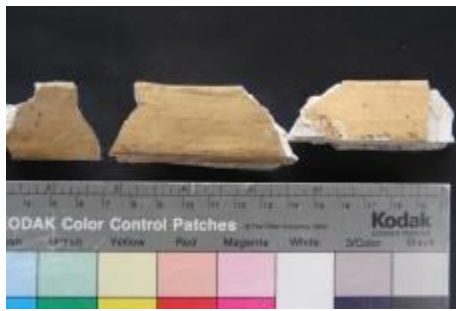
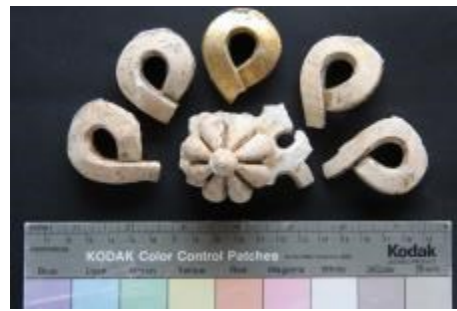
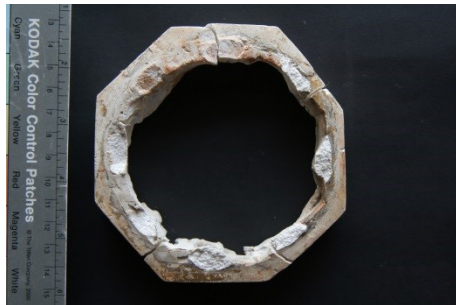
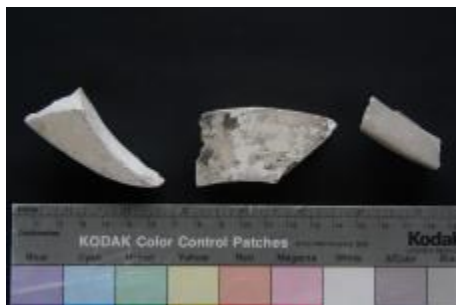
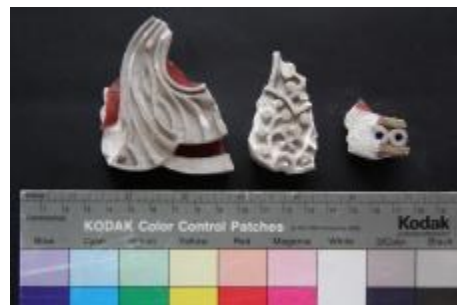
Figure 4.45 - Photographs of the analysed samples from *Bolsa* Palace: (a) PB1; (b) PB2; (c) PB3; (d) PB2+PB3; (e) PB4; (f) PB6

The identification and description of the samples studied is summarized in Table 4.21 and the corresponding images are shown in Figure 4.45.

PB4	1	PB4	Three fragments of white <b>ornaments</b> from the ceiling, less dense than any of the other samples; They presented traces of a blue paint in the base of the side faces that had a different hue in one of them (Figure 4.45, PB4, fragment on the left); That fragment had a much harder surface than the other two, indicating a different preparation; it was rejected with the assumption that it probably resulted from a restoration (with no certainties about that).
PB6	3	PB6/1	<b>Regularization layer</b> applied over the mortar with an average thickness of 6 mm; It presented a textured pattern in the outer face that was printed by the grooves of PB6/2 (Figure 4.46 (a) and (b)).
		PB6/2	Thin layer that is the <b>finishing layer</b> in the surfaces where there are no ornaments (with polychromes) and is the back layer of the ornaments (PB6/3); It was poured sometime after the first slurry (maybe some minutes, as there is a clear interface between PB6/2 and PB6/3), probably to fill the last millimetres of the mould. It had grooves at the back to promote adhesion to the substrate which are the negative of the pattern observed in sample PB6/1 (Figure 4.46 (b)).

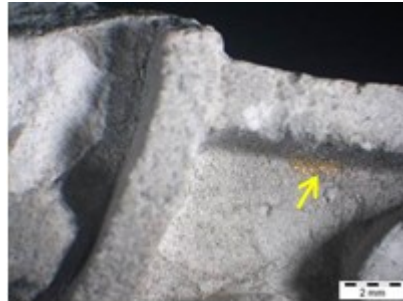
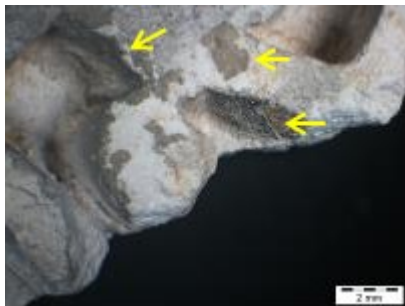
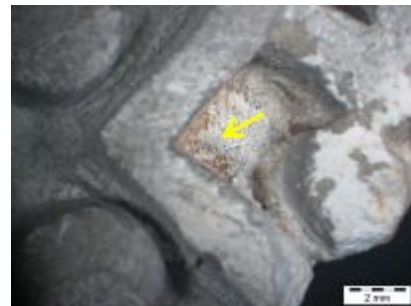
Figure 4.47 - Stereo-zoom microscope images of previous decorative layers in PB6/3: (a) traces of gilding; (b) and (c) white painting, limewash type, over orange pigmented layer

In fact, traces of gilding can be found in the two larger fragments from sample PB6/3 (Figure 4.47 (a)). It is also visible that a white painting layer (lime wash?) now blackened by dust, is covering their surfaces, sometimes over traces of an orange pigmented layer (Figure 4.47 (b) and (c)).

This orange layer was also observed in samples PB2 and PB3. It is most probably due to the material used as preparation layer before the application of the gold leaf, commonly known as “bole”, a supposition that would have to be confirmed by chemical analysis. Other hypotheses are that clay moulds have been used to cast the original ornaments or that clay was pressed against the decoration motifs in order to reproduce parts of them *in loco*, to obtain moulds for the production of new restoration elements.

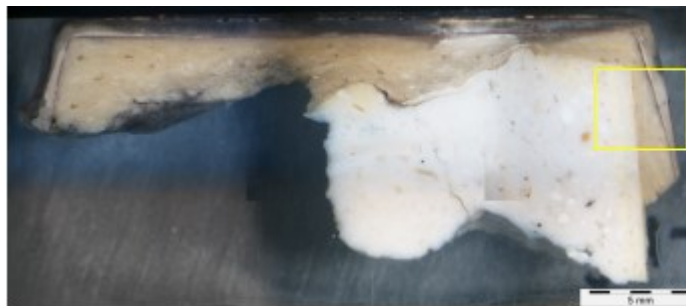
Figure 4.48 - Polished surface of PB1: global view

A cross-sectional polished surface of sample PB1 (Figure 4.48) has been prepared for stratigraphic analysis with the purpose of determining the different layers that compose it.

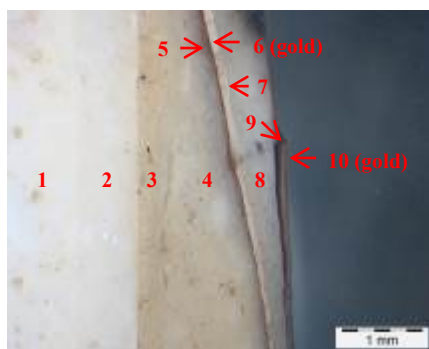
Figure 4.49 - Polished surface images of PB1 (yellow frame of Figure 4.48) with identification of layers: (a) stereo-zoom microscope; (b) FESEM-BSE

Figure 4.49 shows the ten layers observed. A change in the design of the frame due to restoration procedures was also noticed, with the lines of the original piece being slightly straightened.

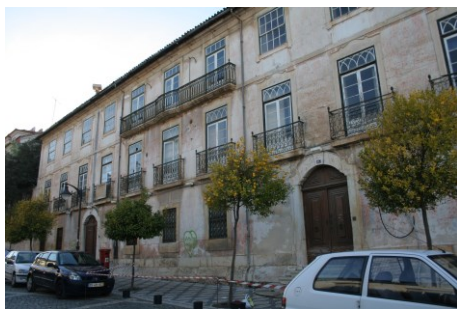
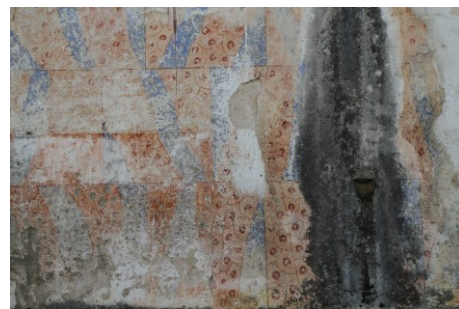
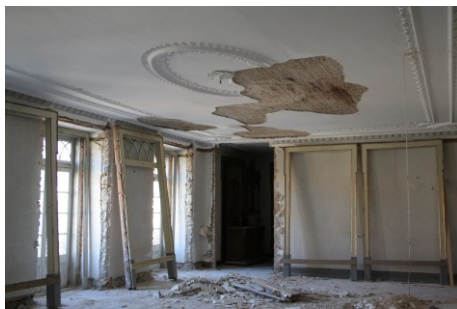
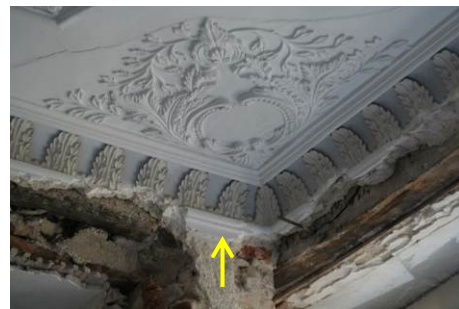
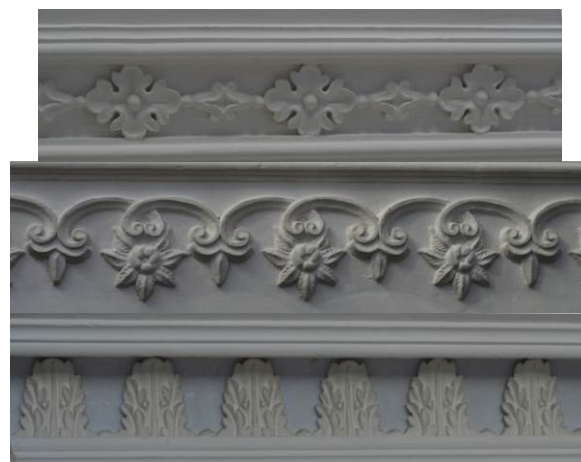
Figure 4.63 - *Barão Salgueiro* Manor house: (a) general view; (b) detail of the façade; (c) assembly room with partially collapsed ceiling; (d) and (e) decorative elements

The main façade was originally painted to simulate a marbled surface that time destroyed remaining now a few traces of a bad restoration work (Figure 4.63 (b)). The entire building is in a poor condition but the intervention already planned has been abandoned due to the economic crisis starting in 2008.

The walls and ceilings' interior coatings are quite simple; only the assembly room (Figure 4.63) and a contiguous small dining room have more elaborated decorative surfaces.

Contrarily to what was observed in the case studies from the 18<sup>th</sup> century, the decorative elements corresponding to sample PBS3 are all similar to each other (Figure 4.63 (d)), having been precast by an “industrial manufacture” process.

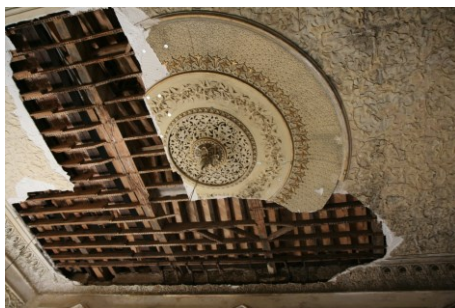
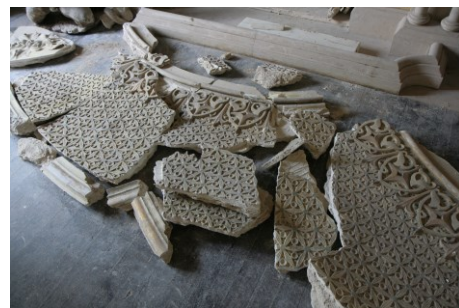
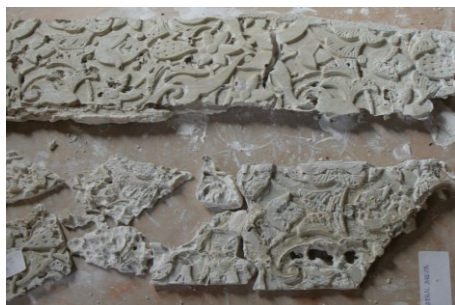
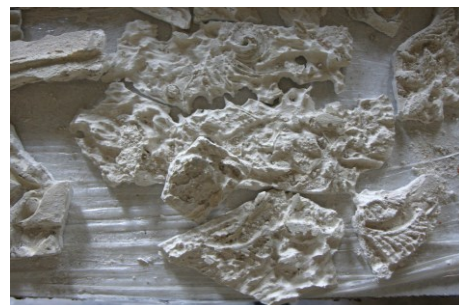
Figure 4.75 - Damage at *Monserrate* Palace before the restoration works: (a) collapsed ceiling of the Indian drawing room; (b) fragments corresponding to (a); (c) and (d) examples of deterioration of some plaster decorations due to long water exposure

The property has not been given the adequate attention for several decades, suffering extensive damage (Figure 4.75).

Unfortunately in *Montserrat* these procedures were not enough to preserve their integrity due to the water exposure of the building for years, leading to the irreversible degradation of many plaster decorations (Figure 4.75 (c) and (d)) and to the rotting of the wooden structure, with consequent collapse of some ceilings (Figure 4.75 (a) and (b) and Figure 4.80 (d)).

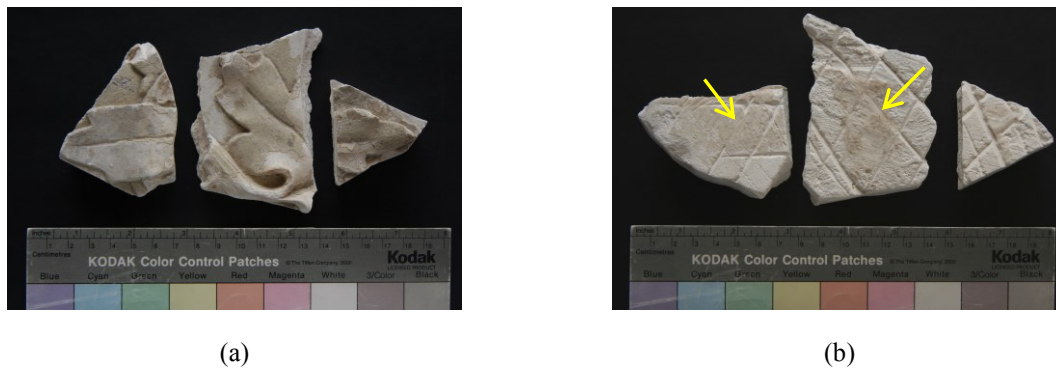
Figure 4.78 - Sample PM2: (a) front view; (b) back view, with synthetic film (yellow arrows)

After initial visual observation, sample PM2 (belonging to precast panels of the totally collapsed ceiling of the south wing hall) was rejected because it raised doubts about being original: the back surface of the fragments had a film of a substance that seemed to be synthetic (not contemporary of the

original decoration) and was probably used to fix the panels to the ceiling during previous restoration works (Figure 4.78).

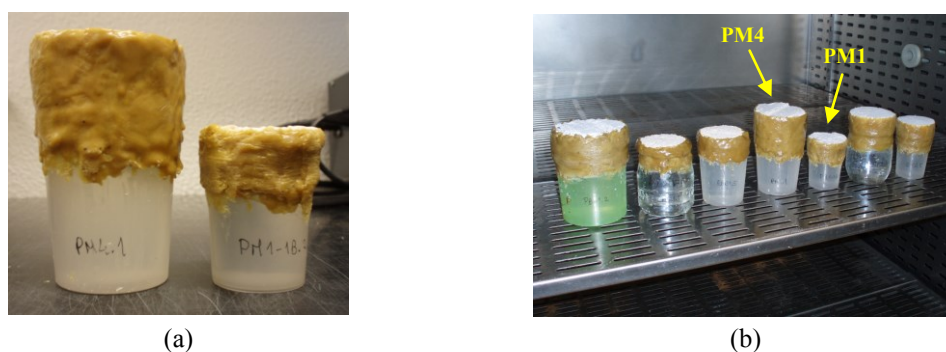
Figure 4.91 - Water vapour permeability determination in samples PM1 and PM4: (a) devices used (adapted to ancient samples); (b) ongoing test

The water vapour permeability was determined in two samples of the *Montserrat* Palace: PM1 and PM4. Both had flat surfaces of test and were available in sufficient quantity. The devices used are shown in Figure 4.91 and the results obtained are presented in Table 4.46.

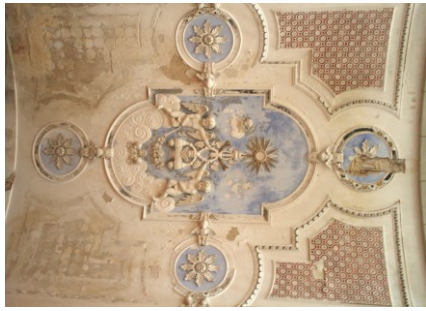
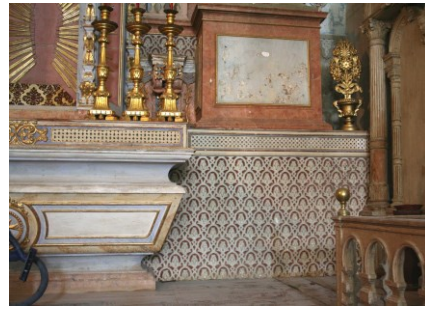
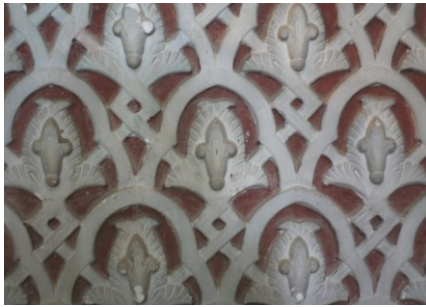
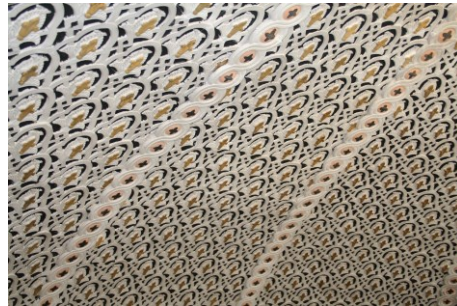
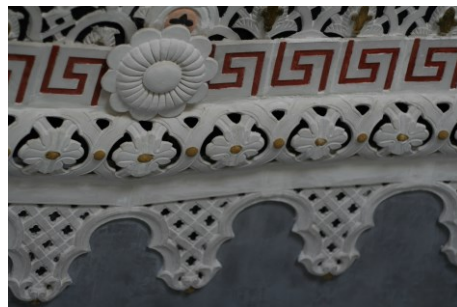
Figure 4.94 - *S. Francisco Church*: (a) ceiling of the presbytery, in poor condition; (b) decorative plasters of the presbytery; (c) and (d) details of some decorative motifs; (e) dome with skylight after restoration; (f), (g), (h) details of the restored decoration of the dome

Two domes stand out at the top. During the reconstruction works that took place at the end of the 19<sup>th</sup> century, the presbytery and the dome close to it were profusely decorated with plaster elements of Neo-Arab influence a job once again authored by *Domingos Meira* (Figure 4.94).

Sample	Description
ISF1	<p><b>Precast ornament</b> representing one “fleur de lis” light-beige coloured, over which there is another “fleur de lis”, gilded, smaller and narrower (Figure 4.94 (g) and Figure 4.96 (a));</p> <p>It seems to have been attached to a smooth surface base plaster, approximately 5 mm thick, painted in black to enhance the decorative effect of the whole (Figure 4.98 (a));</p> <p>The stratigraphic analysis showed that everything has been precast together, i.e. it is only one piece (Figure 4.98 (b)). In fact, looking at Figure 4.95 (b) it can be seen that these ornaments were precast in panels, and then assembled like a puzzle, similarly to what was observed in <i>Montserrat</i> Palace or in <i>Bolsa</i> Palace;</p> <p>It also shows that there is a very thin white layer at the surface of the plaster that seems to have been applied with regularization and/or whitening functions. If this supposition is right, it is probably lime based and its application was immediately after the un moulding, as there is no visible interface with the core of the sample (Figure 4.98 (c)).</p>

ISF2	<p>Three fragments of a <b>precast hollow frieze</b> from the dome with a convex shape representing a floral motive (Figure 4.94 (h) and Figure 4.97 (a));</p> <p>It had few remains of what seems to be a yellow pigmented layer in the flower eye rim (Figure 4.98 (d) to (f));</p> <p>One of the fragments still had the plaster used to fix it behind (Figure 4.97 (b)).</p>
ISF3	<p>Fragment of a <b>precast ornament</b> with a light beige colour and an average thickness of 9 mm (Figure 4.96 (b));</p> <p>It had a small area of the surface with pink coloured biological colonization (Figure 4.96 (b)).</p>

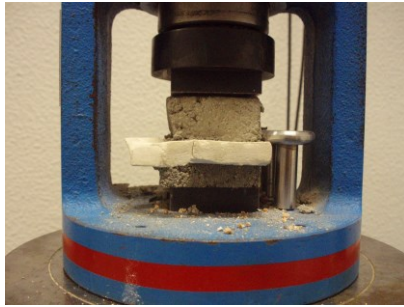
Figure 4.104 - Adapted compressive strength test: ISF3 “sandwiched” between two layers of confinement mortar

The compressive strength has been determined in sample ISF3 (Figure 4.104) and the results are presented in Table 4.55.

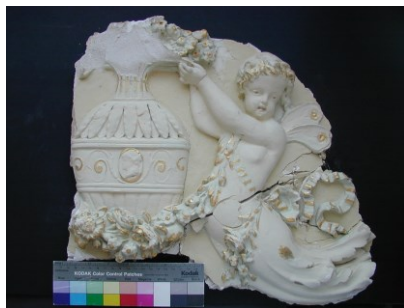
Figure 4.109 - Photographs of the samples PE1 and PE2 from *Estoi* Palace: (a) PE1 (front view); (b) PE1 (side view); (c) PE2 (front view); (d) PE2 (side view)

An additional detail corroborates this hypothesis: in Figure 4.109 (c) the transition between the relieved decorative part of this ceiling and the central pictorial smooth surface, indicated by a red arrow and corresponding to Figure 4.111 (b), shows a blue coloured surface. However, the stereo-zoom microscope observation (Figure 4.111 (c)) indicates that this surface was originally beige, the colour presently exhibited after the restoration works of 2008 (Figure 4.107 (c)).

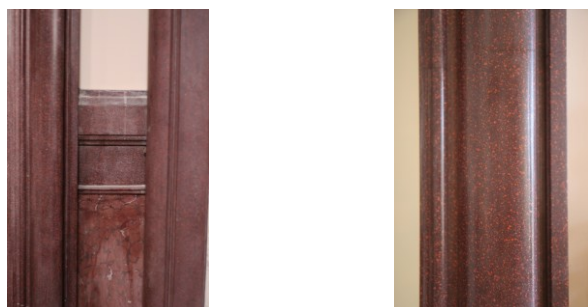
Figure 4.113 - *Estoi* Palace: plaster decorative elements simulating imperial red porphyry in the Noble room

Concerning sample PE4, when looking at it from a front view, it really seems made of stone. The brightness and stiffness of the decorative layer, together with the perfect *porphyry* effect given by the aggregates, are remarkable and highlight the high quality of execution. These aspects were confirmed by the observation of the sample at the stereo-zoom microscope (Figure 4.112 (c)). More detailed images of the visual effect of these elements in the Noble room are presented in Figure 4.113.
