**RESTORATION OF ANCIENT PORTUGUESE INTERIOR PLASTER  
COATINGS: CHARACTERIZATION AND DEVELOPMENT OF  
COMPATIBLE GYPSUM-BASED PRODUCTS**

Thesis approved in public session to obtain the PhD Degree in Civil Engineering

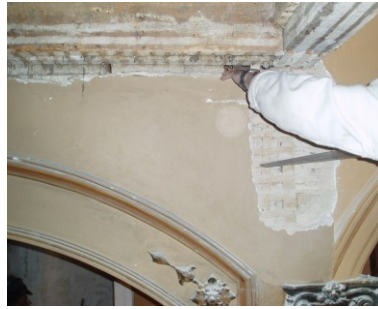
Figure 4.164 - Collection of a sample from the plaster coating of a wall of the *Fafe* Cine-Theatre building

Two samples were collected in two different ways: one consists of three ornaments that have been previously detached due to anomalies in the building and the other is a fragment of a smooth surface wall plaster collected directly on site (Figure 4.164).

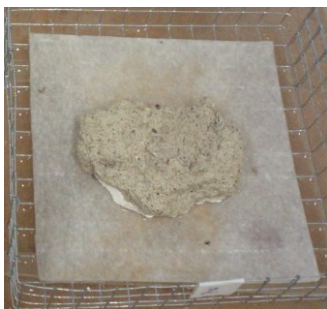
The water absorption by capillarity was evaluated in sample CTF2 (Figure 4.168) and the quantitative results are summarized in Table 4.73.

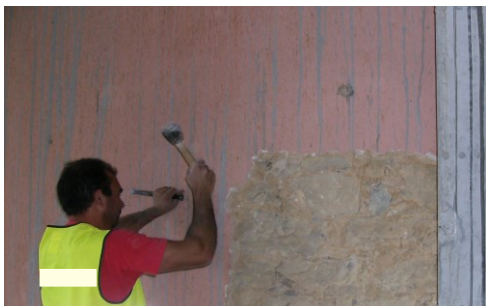
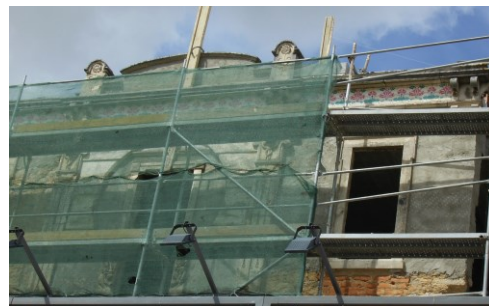
Figure 4.172 - *Garage* building “restoration” works: (a) removal of an interior wall coating; (b) detail of a façade showing the new cement based renders applied and a part of the masonry still uncoated

The interior plaster decoration was very simple and was destroyed in 2008 during the “restoration” works that transformed the building, a former dwelling house of one family, into several apartments and a commercial area (Figure 4.172 (a)). The beautiful stone and ceramic tiles’ work of the façades were the only claddings preserved from the original construction, as the mortars have also been removed (Figure 4.172 (b)).

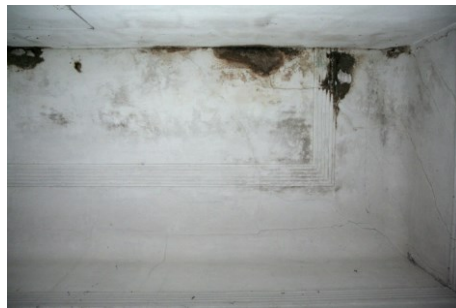
Figure 4.191 - *Beira Rio* building: images of a ceiling (a) and a wall (b) in poor condition

The entire building is in a poor condition (Figure 4.191) but the intervention planned for its recovery has been delayed due to the economic crisis installed since 2008.

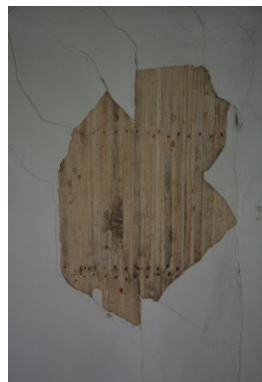
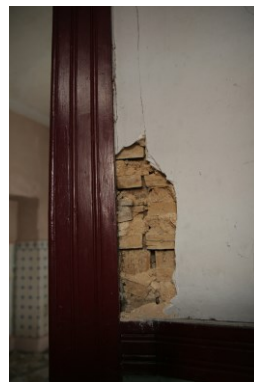
Figure 4.192 - Some places in the *Beira Rio* building corresponding to the samples collected: (a) partially collapsed ceiling of the *hall* of the service entrance; (b) wall of the same room as (a)

A total of three samples were collected in two different ways: indirectly, as they were already detached due to some anomaly in the building (two samples, one of them corresponding to the area shown in Figure 4.192 (a)) and directly on site (Figure 4.192 (b)).

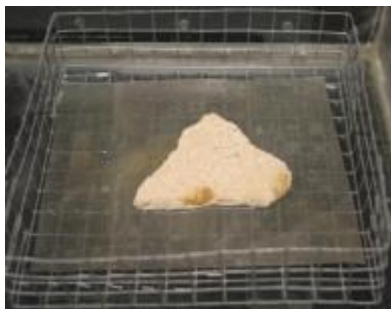
The water absorption by capillarity was determined in two samples from the *Beira Rio* building (Figure 4.197) and the quantitative results are summarized in Table 4.90.

The EBR3 curve (Figure 4.197 (c)) is similar to those of samples CP2 (Figure 4.26 (b)) and PB4 (Figure 4.59 (b)): there is a high initial absorption rate, typical of a material with significant amounts of pores of higher dimensions ( $r > 0.5$  micron) that slows down to small absorption rates after the first 10 minutes, typical of smaller pores; if the absorption is still not stabilized at the end of the procedure (24 h) it means that the content of smaller pores is also high.

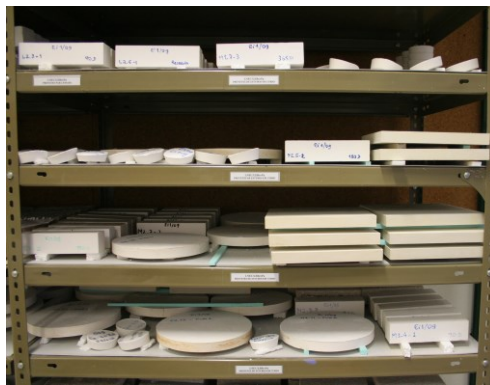
Figure 5.2 - Storage of the test specimens in conditioned environment

The test specimens of hardened product were stored in a room with conditioned environment at a temperature of  $23 \pm 2^\circ \text{C}$  and relative humidity of  $50 \pm 5\%$  (Figure 5.2). All tests were performed in the same room with the exception of the mechanical properties that were evaluated in a room at a temperature of  $20 \pm 2^\circ \text{C}$  and relative humidity of  $65 \pm 5\%$ .

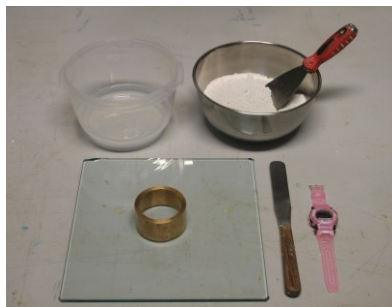
Figure 5.3 - Determination of the plaster/water ratio using the dispersal method: (a) apparatus; (b) measuring the diameter of the pat formed

The **plaster/water ratio** (P/W) of the several mixes was determined according to EN 13279-2:2004 using the dispersal method in the fluid products (P series, mainly based on gypsum) (Figure 5.3) and the flow table method in the paste products based on mixtures of gypsum and hydrated lime (M and L series) (Figure 5.4).

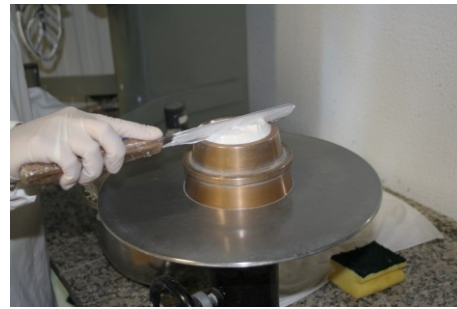
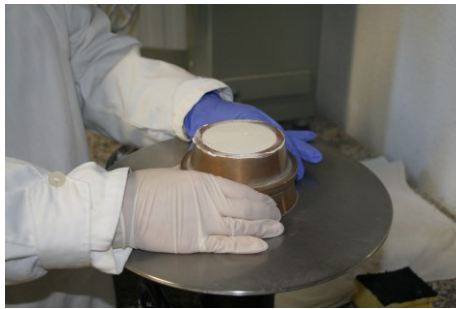
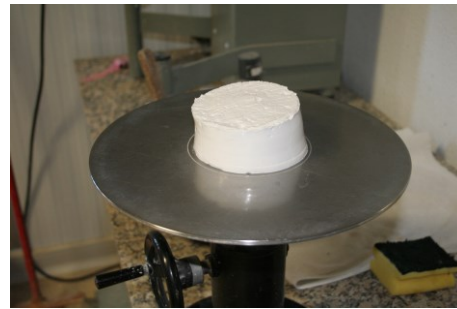
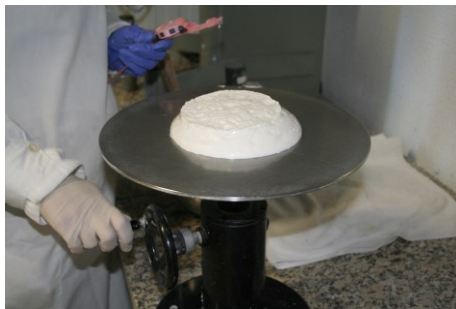
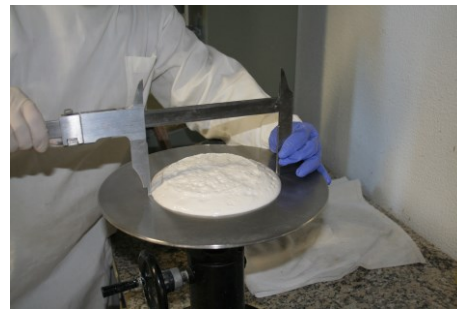
Figure 5.4 - Determination of the plaster/water ratio using the flow table method: (a) pouring the plaster into the slump cone; (b) removing the excess plaster with a spatula; slump cone before (c) and after (d) being withdrawn; (e) application of the vertical blows (f) measuring the diameter of the pat formed

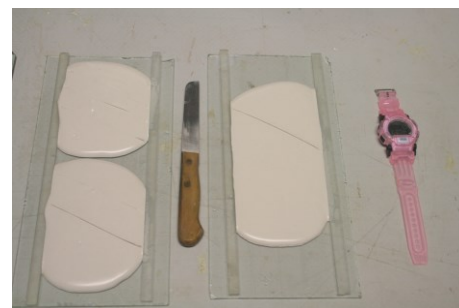
Figure 5.5 - Determination of the setting time using the knife method: (a) two plasters for trial cuts (left) and one plaster for the test cut (right) immediately after pouring the plaster on to the glass plates; (b) the same as in (a), after the end of the procedure

The **setting time** was determined according to EN 13279-2 using the knife method (Figure 5.5).

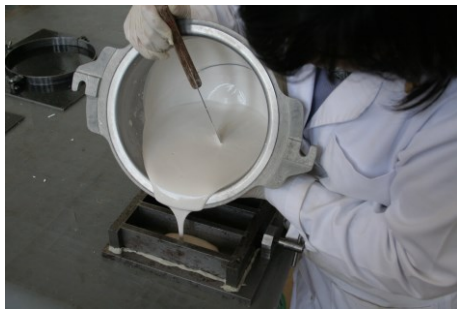
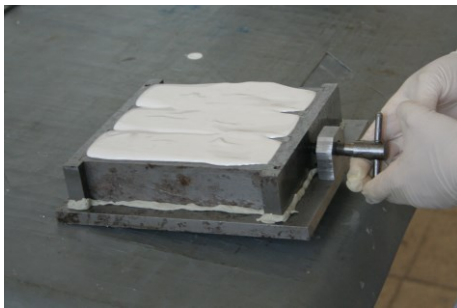
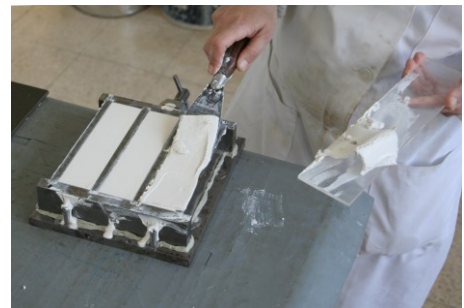
Figure 5.6 - Preparation of the prismatic test specimens: (a) pouring the plaster into the mould; (b) and (c) compaction procedure; (d) removing the excess plaster with a palette knife; (e) test specimens before demoulding; (f) procedure completed

The **prismatic test specimens of hardened product** were prepared according to EN 13279-2:2004 using the steel moulds indicated in NP EN 196-1:2006 (Figure 5.6).

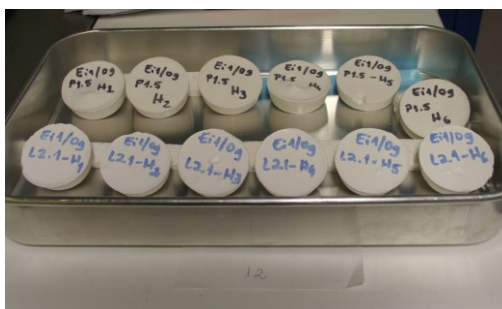
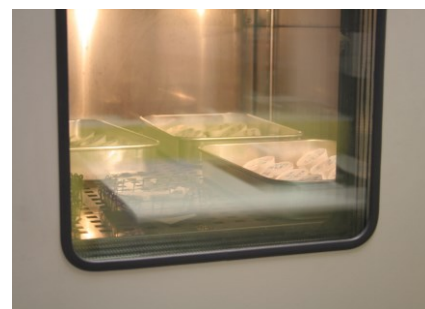
Figure 5.10 - Determination of the hygroscopic behaviour: (a) and (b) preparation of the test specimens; (c) weighing procedure; (d) device used to accommodate test specimens in the climatic chamber; (e) ongoing test inside the chamber

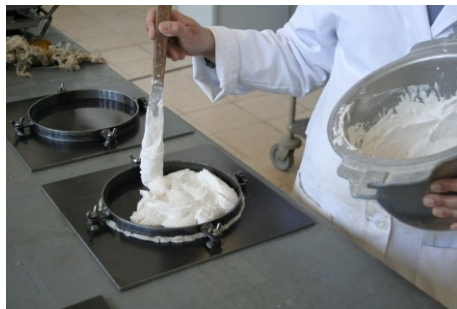
The **water vapour permeability** was determined at 90 days and 2 years using the method described in EN 1015-19:1998, with few adaptations (Figure 5.11). This method is based on the measurement of the water vapour flux through the samples due to the pressure differential between the internal (relative humidity approximately 100%) and the external surface (relative humidity =  $50 \pm 5$  %), at  $20 \pm 2$  °C.

The 100% relative humidity conditions inside the test cups were achieved with water, and are considered to originate a water vapour saturated atmosphere. The vapour flux is quantified by the weight variations of the test devices at fixed time intervals.

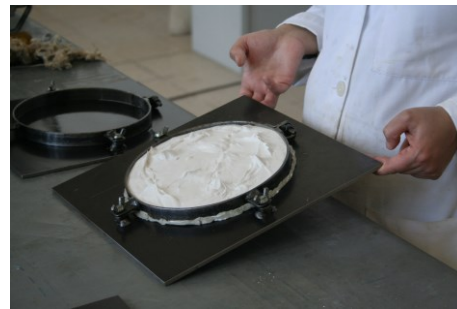
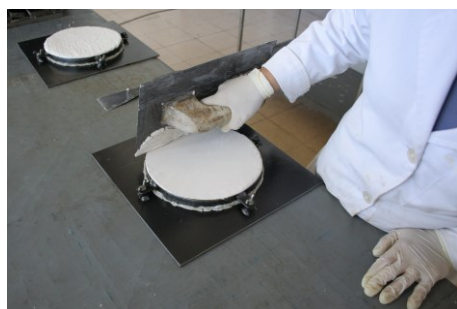
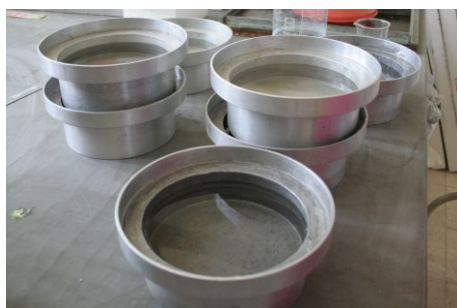
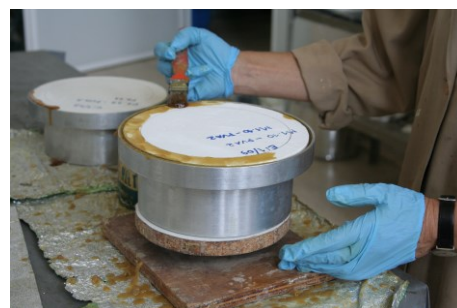
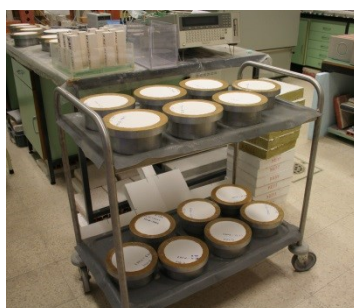
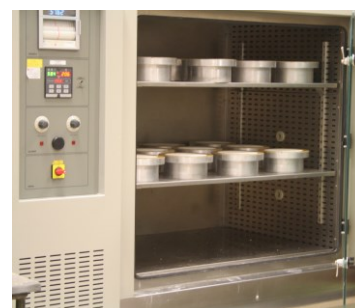
Figure 5.11 - Determination of the water vapour permeability: (a) to (d) preparation of the test specimens; (e) test cups filled with water; (f) application of the insulating material; (g) devices after completing the preparation; (h) weighing procedure (i) in the climatic chamber

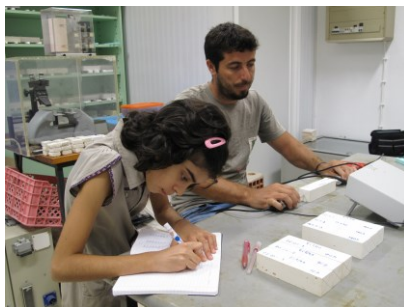
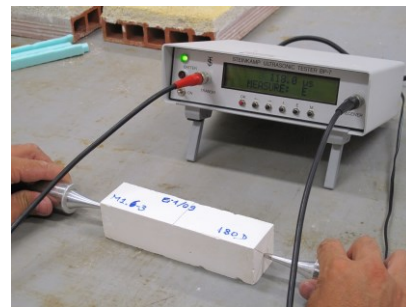
Figure 5.14 - Determination of the dynamic modulus of elasticity by measuring the speed of propagation of ultrasound waves: (a) general view of the ongoing procedure; (b) detail of the measurement

- The one already used in the ancient samples, based on the measurement of the speed of propagation of longitudinal ultrasonic waves through laboratory prepared standardized test specimens, where the distance between the transducers was always about 160 mm, allowing the calculation of elastic parameters (NP EN 12504-4:2007) (Figure 5.14);
- The method based on the measurement of the fundamental resonance frequency of the material subjected to longitudinal vibrations (NP EN 14146:2006) (Figure 5.15).

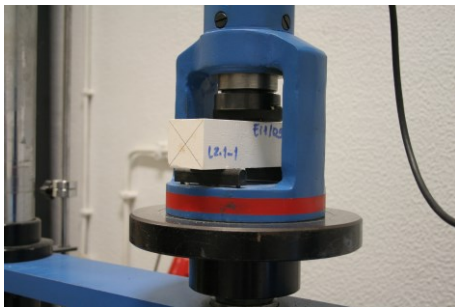
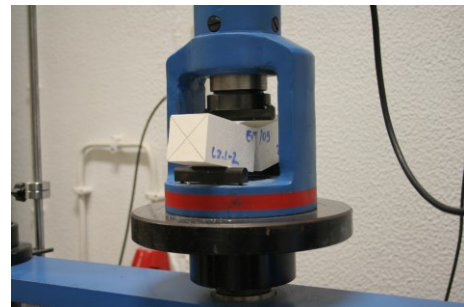
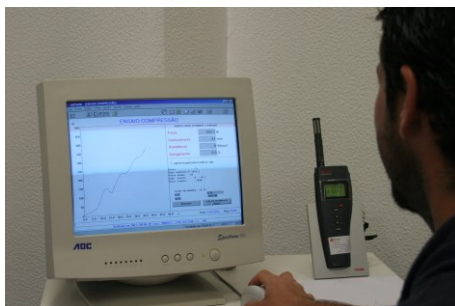
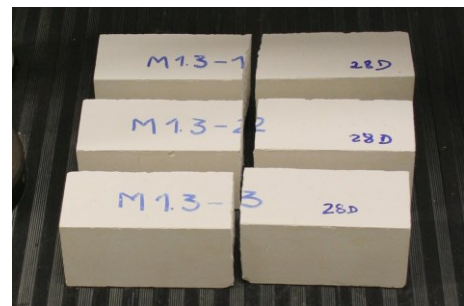
Figure 5.16 - Flexural strength tests: (a) device used with a test specimen positioned to be tested; (b) after failure of the test specimen; (c) graphical representation of the material's behaviour during load application; (d) semi-prisms resulting from a determination

The test specimens used in the dynamic modulus of elasticity determinations were then subjected to **flexural and compressive strength** tests in the same electromechanical device as the ancient samples (Figure 5.16 and Figure 5.17).

The loading rates were adjusted so that failure occurred within a period of 30 to 90 s (EN 1015-11), between 10 and 25 N/s in the flexural strength and between 50 and 200 N/ in the compressive strength tests (Table 5.3). Load cells of 2 kN and 200 kN were used, depending on the mechanical characteristics of the product.

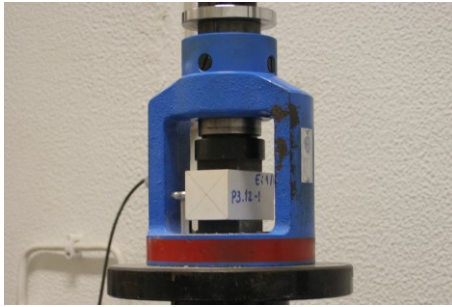
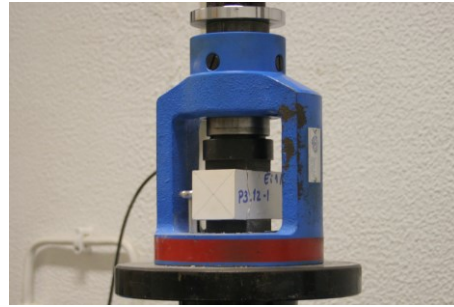
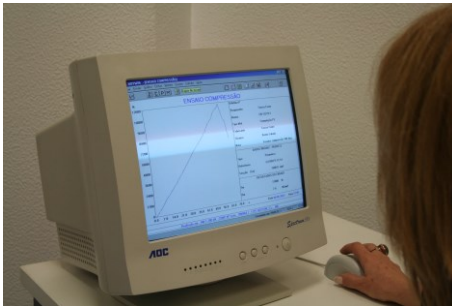
Figure 5.17 - Compressive strength tests: (a) device used with a semi-prism positioned to be tested; (b) the same, after failure of the test specimen; (c) graphical representation of the material's behaviour during load application; (d) appearance of the test specimens at the end of the mechanical strength procedures

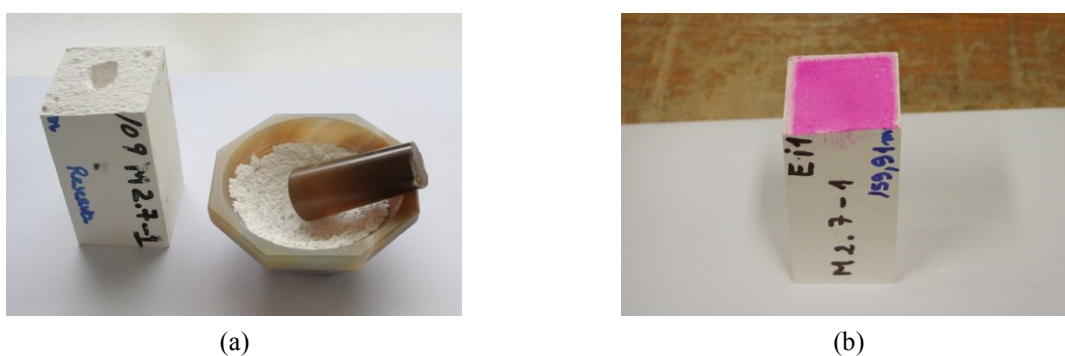
Figure 5.18 - Evaluation of the carbonation process: (a) preparation of samples for TG-DTA analysis; (b) surface of a test specimen a few seconds after being sprayed with phenolphthalein

Samples of the inner core of one of the resulting halves of freshly broken prismatic test specimens were collected and milled in an agate mortar until all the powder particles passed through a sieve of 106 microns (Figure 5.18 (a)). They were placed in sealed plastic bags and stored in a desiccator.

The surfaces of the other half prisms had been sprayed with phenolphthalein (1%) alcoholic solution (prepared with 30% water and 70% ethanol) for evaluation of the carbonation front (Figure 5.18 (b)).

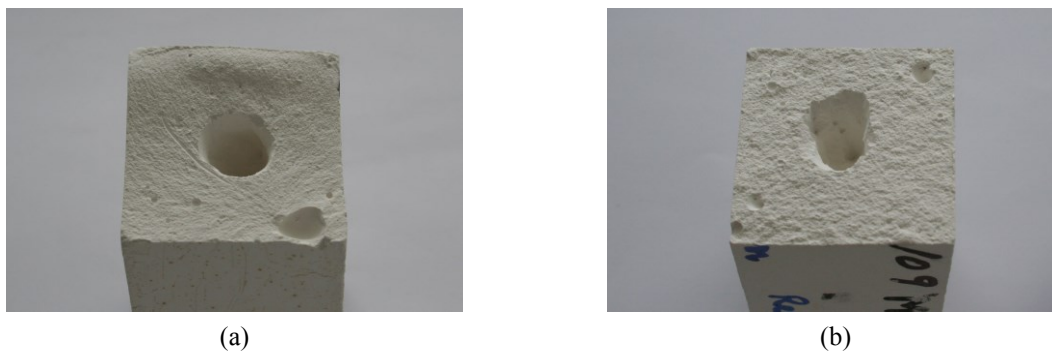
Figure 5.25 - Surfaces of test specimens after failure showing textural differences: (a) L1; (b) M2

Still concerning Figure 5.24, a different texture of the surfaces of L1 and L2 compared to those of M1 and M2 can be observed. The strong fuchsia colour imprint of phenolphthalein makes the surfaces of the first group seem to be rougher than those of the second one, while in practice it is exactly the opposite (Figure 5.25). This is probably another effect of the different carbonation distribution through the microstructure of the materials.

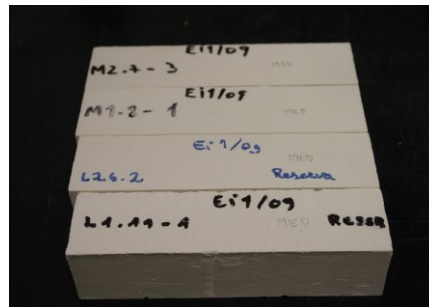
Figure 5.38 - Comparison between dimensional variations in L and M test specimens (visible to the naked eye)

The dimensional variations observed are according to expectations: the higher the lime content (and lower the gypsum content), the higher the shrinkage (Figure 5.38). Even though, the values obtained for the mixes L1 and L2 are much higher than usually observed in lime mortars (maximum shrinkage of approximately 5 mm/m (Faria 2004)).
