Science and Art: A Future for Stone

**Proceedings of the 13th International Congress on the
Deterioration and Conservation of Stone – Volume II**

6th to 10th September 2016, Paisley, Scotland

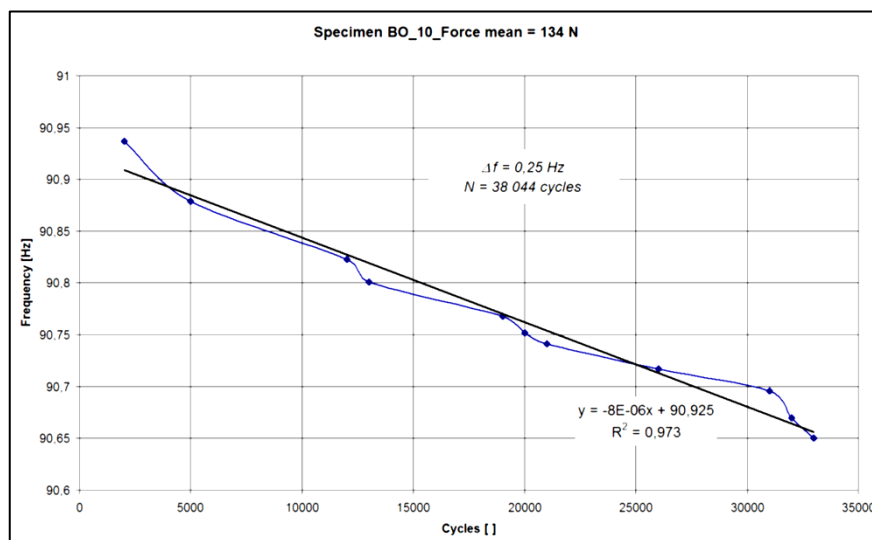
Cycling the specimens in the high frequency resonance loading frame helped to understand fatigue behaviour of the Božanov sandstone. At a given force level (3PB arrangement under point load cycling from -10 N to -260 N) the majority of specimens exhibited fatigue life in a range between 90 000 and 140 000 cycles. However, there were specimens with one order lower or higher fatigue life due to the heterogeneity of the sandstone. To prepare the test specimens, a lower number of loading cycles was applied (between 32 000 and 40 000), and only specimens exhibiting behaviour similar to those of the above mentioned majority were accepted for further experiments. A typical record of the change of resonance frequency is presented in Fig. 3. Visible steps are the results of the regulation loop reaction which keeps the mean loading value within an interval of +/- 2 N.

Fig. 3: Decrease of loading frequency during cycling of the specimen BO_10 (for 134N).

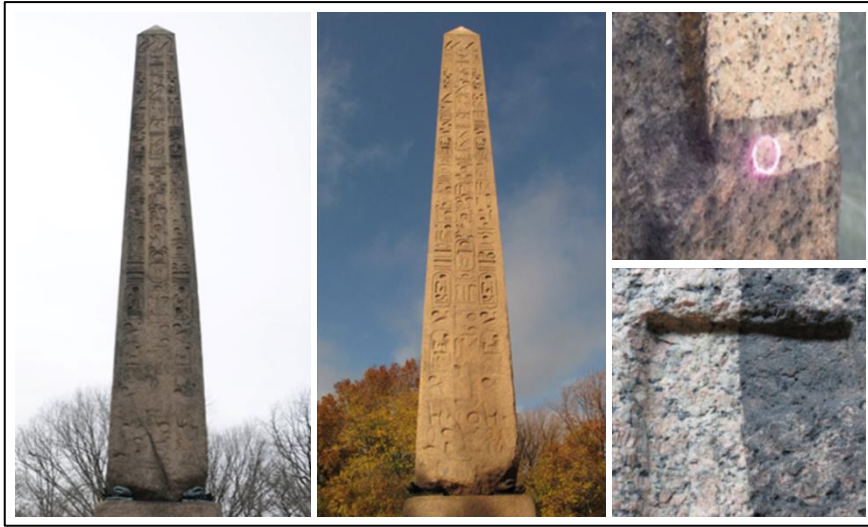
The granite surface was examined with a portable USB microscope during treatment to ensure that no damage was being done to the surface. Photomicrographs were taken to document the cleaning results. Fig. 9 shows a one area before and after laser cleaning in regular light and infrared light. IR light helps show carbon on a surface. The images show that the soiling was successfully removed and that the black biotite inclusions, pink quartz, white quartz, and other minerals were not damaged during the cleaning process. In fact, the green arrows point to two small grains of quartz on the surface which are not disrupted at all by the cleaning process and remain intact.

Fig. 8: Overall and detailed results of laser cleaning the obelisk.

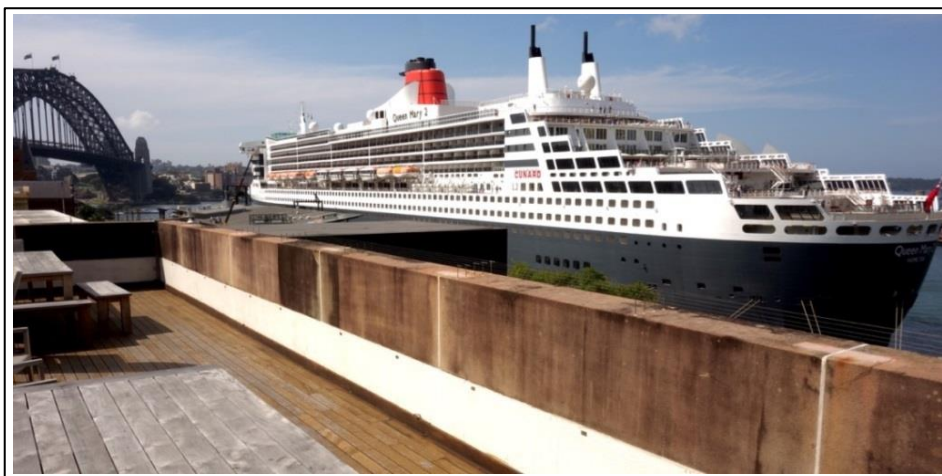
Fig. 2: The eastern wall of the balcony, 23 months after treatment. The dark area left of centre is the untreated control panel; to its left are panels treated by poultice application of biocide. Note the wide zones around the mortar joints showing a biocidal effect of the alkaline jointing material.

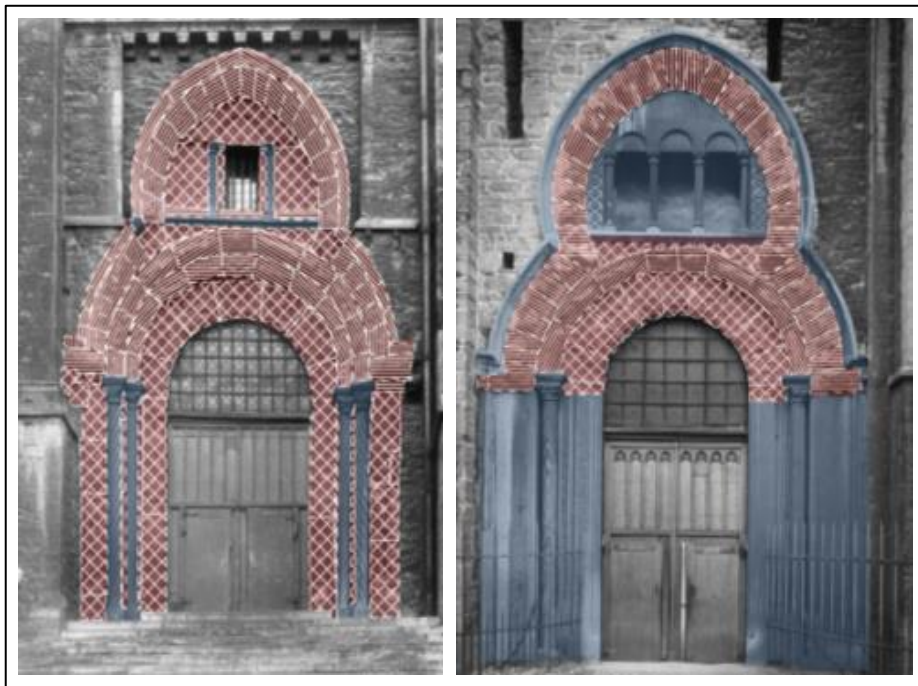
Fig. 3: Mapping of the bedding planes of the original stone blocks in the Mantile (left) and Capitole portal (right). Hatchings underlines the bedding planes, while crosshatching is used for face-bedded blocks. Blue-coloured zones correspond to the 19th century restoration with Belgian bluestone ©KIK-IRPA, Brussels.

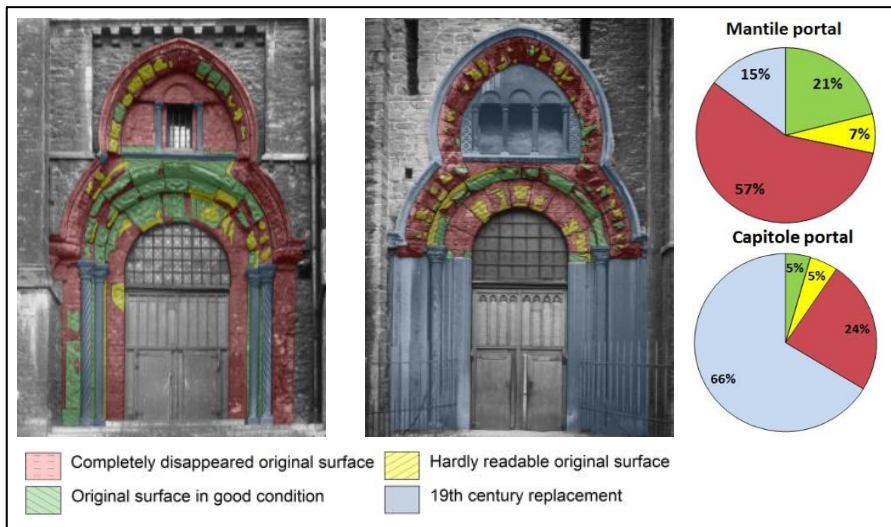
Fig. 5: General mapping and diagrams of the state of conservation of the sculpted surface. Mantile portal (left) and Capitoile portal (right) © KIK-IRPA, Brussels.

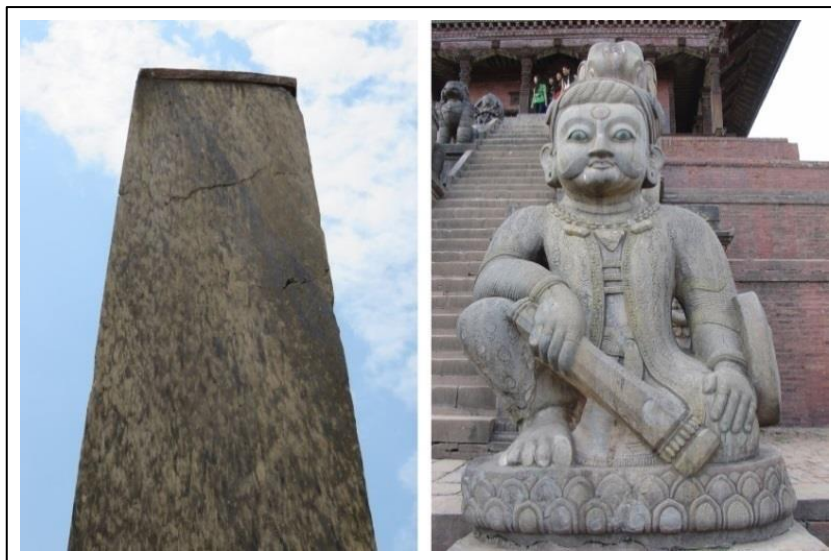
Fig. 2: Decay patterns and typical construction of monuments made of the metamorphic stone.
