Capacity building for the documentation and conservation of Latin American cultural heritage: making technology accessible and sustainable

The contribution provides two case studies of UNESCO Cultural Heritage Places located in Colombia:

- (1) Recording hypogea's mural paintings at the National Archeological Park of Tierradentro and
- (2) Recording the as-found condition of the carved rock phase of the Lavapatas Fountain at the San Agustín Archaeological Park.

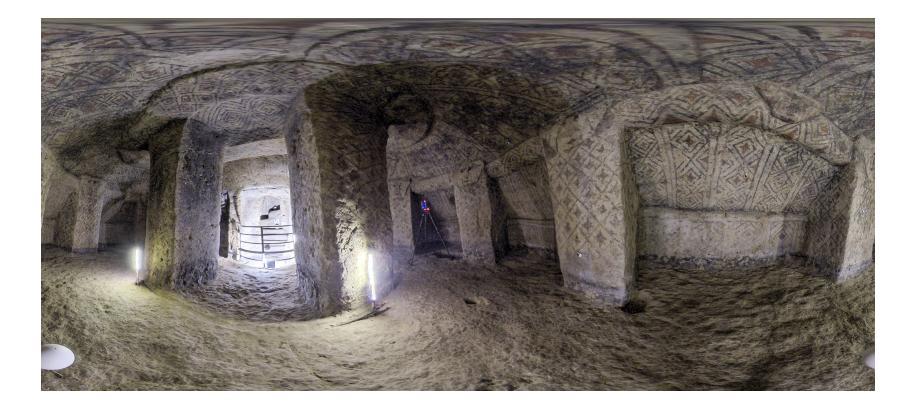
Plate 1. 360 panoramic image inside a hypogea (Tierradentro Archaeological Park)

The archaeological park consists of collective underground tombs, commonly named hypogea (Plate 1), which seem to reproduce the interior of a house. These constructions are vestiges and unique works in the world; for this reason, the park was included on the World Heritage Site in 1995 by UNESCO under criteria III (UNESCO, 1995a).

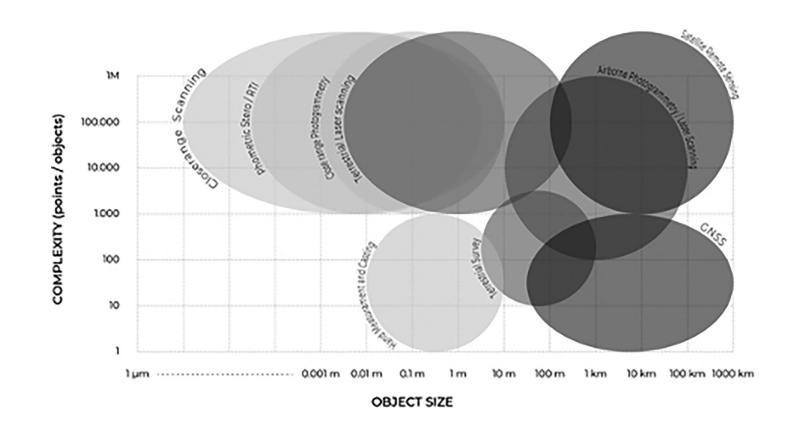
Figure 1. Suitable surveying methods considering object size and object complexity (Boehler and Heinz, 1999) adapted by the author for decorated surfaces documentation

The workshop, led by Mario Santana Quintero and Miquel Reina Ortiz, was attended by a group of interdisciplinary Colombian professionals (Plate 4). The main goal of the collaboration was to teach different digital recording techniques applied explicitly to wall paintings and carved elements and document both sites. To that end, the course started with a diagram – that includes all the suitable surveying methods considering object size and object complexity – to present comprehensive documentation approach of decorated surfaces approach (Figure 1).

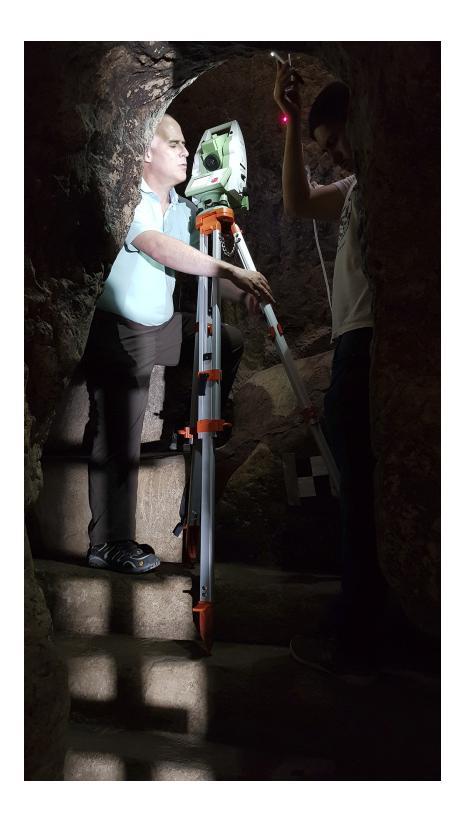
Plate 5. Setting up the total station in a challenging area to connect the inside to the outside (Tierradentro Archaeological Park)

The survey was performed using a Reflectorless Electronic Distance Measurement Total Station Leica Geosystems model Viva TS11 to generate a survey network that orient, scale and connect the different generated datasets: 3D laser scanning, aerial and terrestrial photogrammetry. In both historical sites, a set of interior and exterior ground control points was measured. In the interior of the hypogea, different natural features were used as control points to protect the wall painting and to avoid direct contact with the surface (Plate 5).

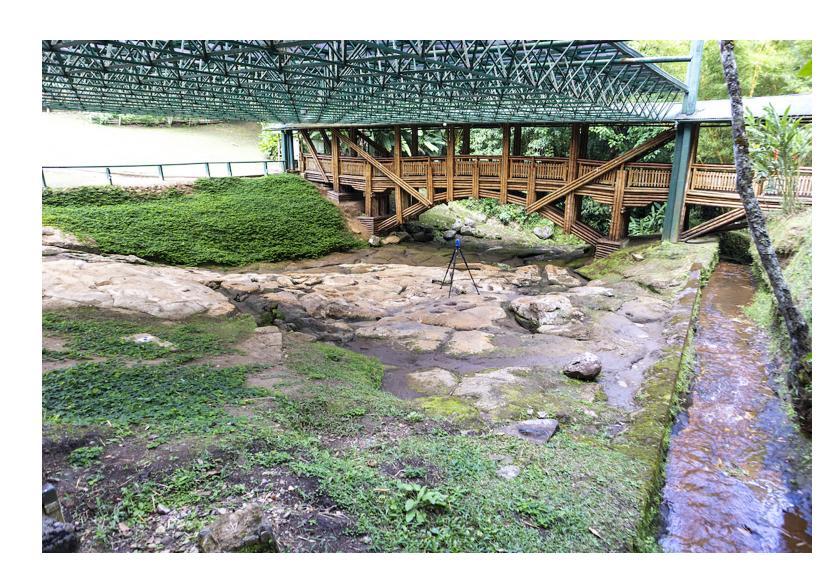
Plate 6. Laser scanning to record the Lavapatas Fountain (San Agustín Archaeological Park)

The 3D Laser Scanning was executed using a highly portable high-resolution phasecomparison scanner Faro Focus 3D CAM2 HDR X 330 with an accuracy of ranges between $\pm 2-7$ mm. It was used for both exterior and interior space of both sites. In addition to the scanning process, different 360° photographs are taken to assign color to the scan points and improve the readability of the Point Cloud (Plate 6).

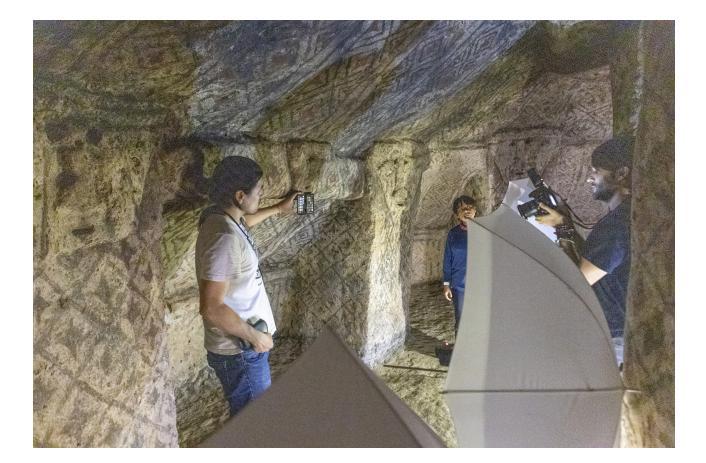
Plate 7. Color correction for the photogrammetric survey (Tierradentro Archaeological Park)

The RPAS flight path allows taking overlapping images using a double grid and a flight height of 20 and 35 m. The photographs for the terrestrial – or close-range high definition photogrammetry – were taken with a Nikon 800 with a 20mm lenses. Given the challenging light conditions inside the hypogea, a set of four flashes with umbrellas diffusers per camera mounted on a tripod were used to control lighting and generate a homogeneous exposure on the surface. To achieve a correct color fidelity, a color card (X-Rite Color Passport) was used to control the photograph's white balance and color-correct them.

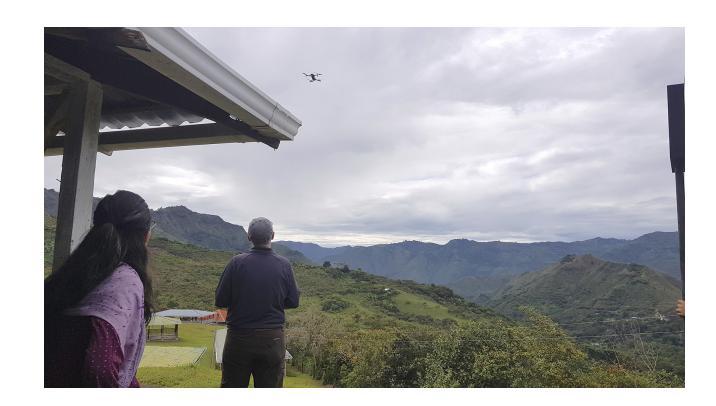
Plate 8. RPAS deployed to map the Alto de Segovia (Tierradentro Archaeological Park)

Aerial photogrammetry was performed with a remotely-piloted aircraft system (RPAS) or as commonly known as a drone. The selected RPAS model was a DJI Mavic Pro 2. This device is very portable and equipped with a sophisticated Hasselblad camera with high photographic resolution (Plate 8).

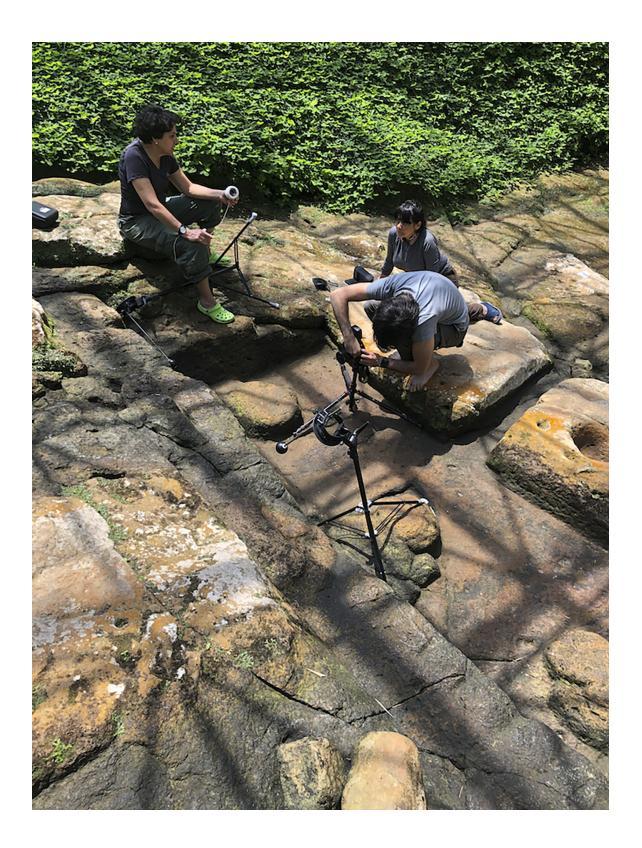
Plate 9. Utilizing RTI on the Lavapatas Fountain (San Agustın Archaeological Park) the possibility of generating panoramic tours. For this project, the Insta360 One X camera was used, allowing the automatic production of 360° panoramic images.

Reflectance transforming imaging (RTI) – a photography-based visualization technique – was used to document small surface variations. This technique involves taking a series of photographs from a still point with varying light positions to digitally re-lit the documented area in real-time. Apart from a DSLR camera and flashes, this process requires a specific toolkit formed by black reflecting spheres, fixing devices and measuring rope (Plate 9).

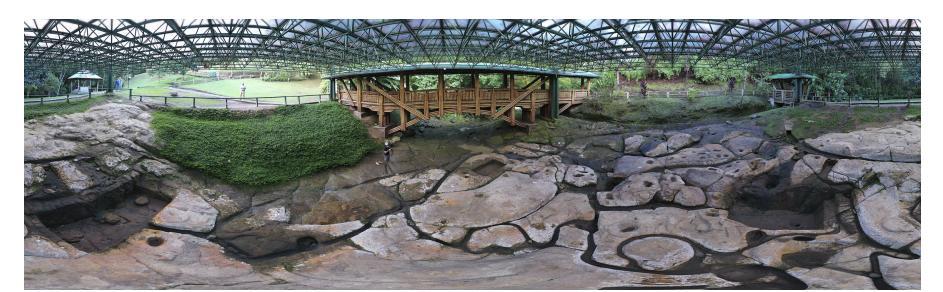
Plate 10. Panoramic photograph of Lavapatas Fountain (San Agustín Archaeological Park)

After an intensive four-day workshop capturing all the data required, the workshop group drove south to the archaeological site of San Agustín to document the ceremonial fountain of Lavapatas. This natural area is placed in the Colombian Massif on the southwest of the Andes in the Huila department, which features the largest complex of pre-Columbian megalithic structures in the region. This second part's objective was to document the Spring of Lavapatas – a natural site used for ancient religious ceremonies and baths. A series of pools and channels are carved into the stone to channel the water with human and animals' motives. During a day and a half – and despite a brief torrential downpour – the group surveyed with a total station, laser scanner and conducted terrestrial and aerial photogrammetry and RTI. With the documentation, an accurate 3D digital reconstruction of the area will be constructed to monitor its rapid degradation level (Plate 10).

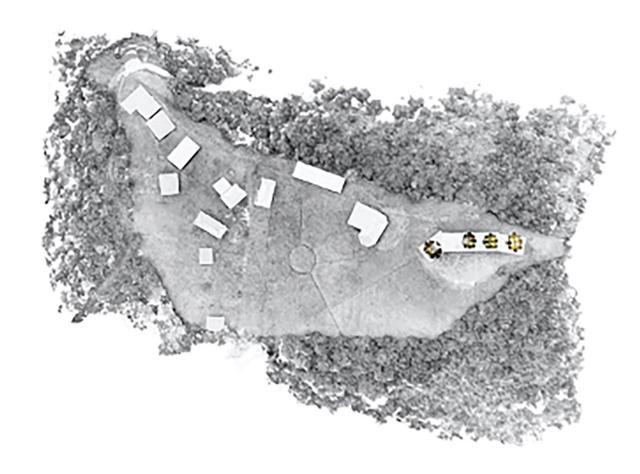
Figure 2. Alto de Segovia with the documented hypogea (S9, S10, S11 and S12) (Tierradentro Archaeolexical Parle) Archaeological Park)

For these reasons, the Instituto Colombiano de Antropología e Historia (ICANH) and the Universidad del Externado (UC), based on the measured drawings produced in collaboration with the CIMS, developed a condition assessment strategy (Figures 2-7 and Plate 11).

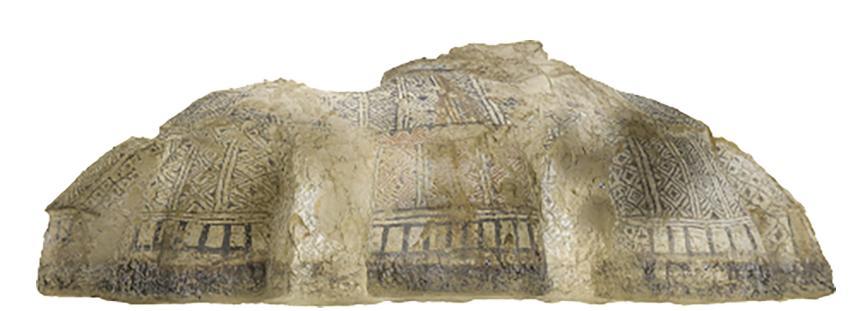
Figure 5. Longitudinal section ortho-corrected image of the hypogea S12 (Tierradentro Archaeological Park)

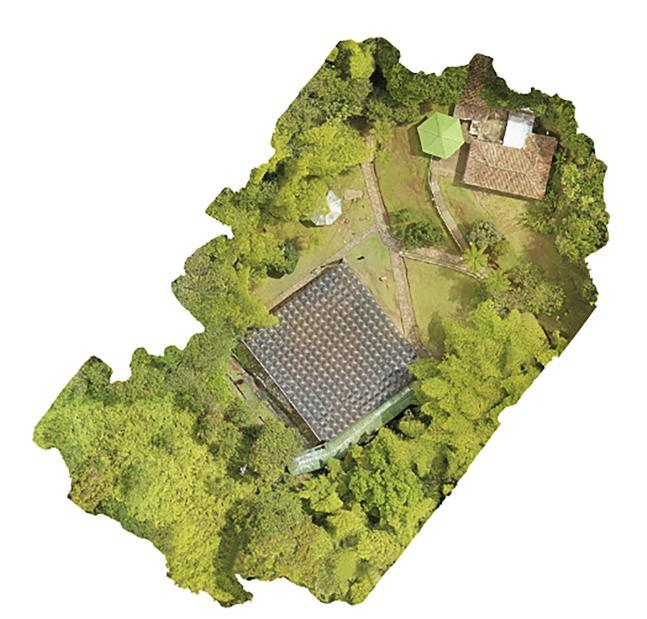
Figure 6. Site ortho-image of Lavapatas Fountain (San Agustín Archaeological Park)

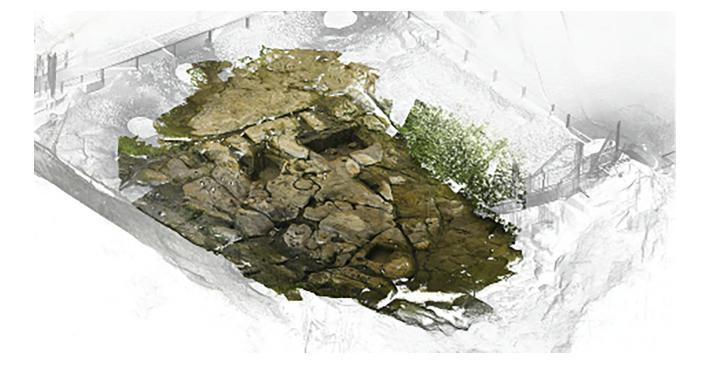
Figure 7. Dense point Cloud of Lavapatas Fountain (San Agustín Archaeological Park)
