# AN INNOVATIVE PHOSPHATE-BASED CONSOLIDANT FOR LIMESTONE. PART 1: EFFECTIVENESS AND COMPATIBILITY IN COMPARISON WITH ETHYL SILICATE

Enrico Sassoni<sup>\*</sup>, Gabriela Graziani, Elisa Franzoni

Department of Civil, Chemical, Environmental and Materials Engineering (DICAM), University of Bologna, Via Terracini 28, 40131, Bologna (Italy)

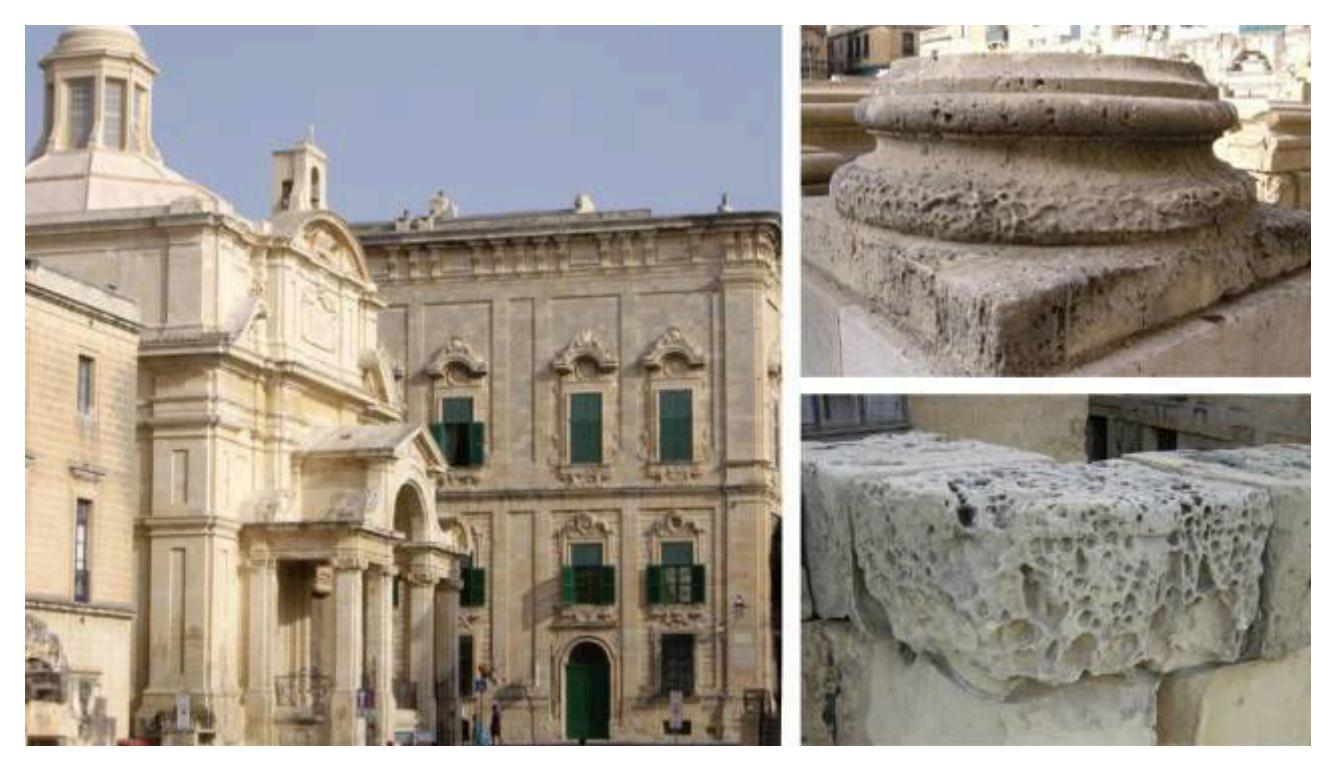
Figure 1. Example of use of Globigerina limestone in historical architecture in La Valletta (Malta) and details of severely weathered architectural elements.

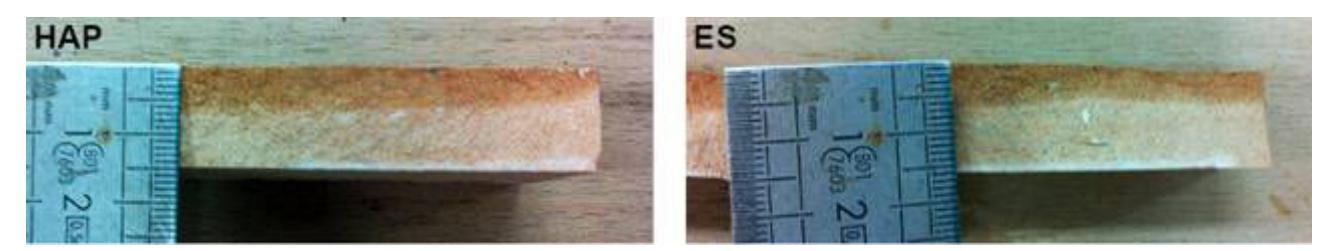
**Figure 2**. Penetration depth of the two treatments, as assessed by fracturing freshly treated samples (the zone reached by the consolidants are darker than the substrate).

<u>Penetration depth</u>. For both the DAP solution and ES, a penetration depth around 7 mm was found right at the end of the treatment (Figure 2) and a uniform penetration was observed. After curing, results of MIP and FT-IR analysis (Figures 3-4 and Figure 5, respectively, commented below) indicate that penetration depth increased to at least 10 mm for both consolidants, suggesting that consolidant further penetration and distribution in the stone took place after the end of the treatment. This is owing to the fact that consolidants are absorbed quickly into larger pores and then are gradually drained into smaller pores, which may lead to significant additional penetration [16].

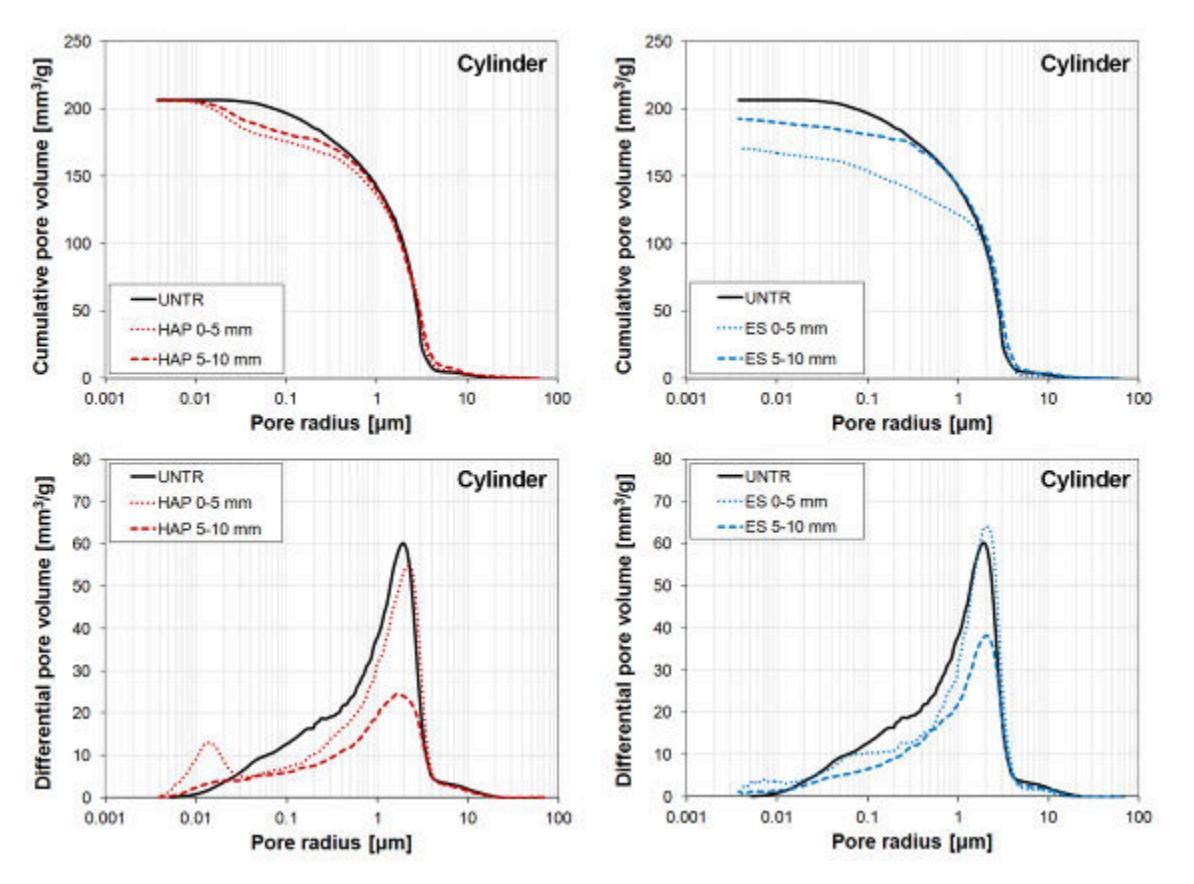
**Figure 3**. Pore size distribution of untreated and treated cylindrical samples (for each condition, two samples were analyzed, collected at a depth of 0-5 and 5-10 mm from the treated surface).

<u>Microstructure</u>. The effects of the HAP- and ES-treatments on the pore size distribution of treated samples are illustrated in Figure 3 (cylindrical samples) and Figure 4 (cubic samples), in terms of both cumulative and differential pore volume. Firstly, it can be observed that alterations induced by the treatments were much more pronounced in cylindrical samples than in cubic ones, consistently with the fact that, at the end of brushing application, cylinders were almost entirely filled with consolidating solutions, while cubes were far from saturation (Table 1). In accordance with results of abrasion tests (cf. § 3.1), MIP curves of cubic samples (Figure 4) show a gradual microstructure modification, passing from the surface layer (0-5 mm) to the underlying layer (5-10 mm) to the most internal one (10-15 mm), suggesting that no surface clogging layers were formed after treatment. For the 10-15 mm layer, curves of treated and untreated samples basically overlap, which further indicates that treatments penetration depth was about 10 mm.

In the case of cylindrical samples, almost entirely consolidated, alterations in total open porosity and volume of pores within different ranges are reported in Table 5. The ES treatment partly occluded pores, especially in the surface layer of the sample: total open porosity decreased from 37.3% (untreated reference) to 30.7% (surface of the ES-treated sample). Differently, the HAP-treatment left the total open porosity essentially unaltered, even if it caused some modifications in the pore range between 0.01 and 0.2 µm (especially in the surface layer, Figure 3).

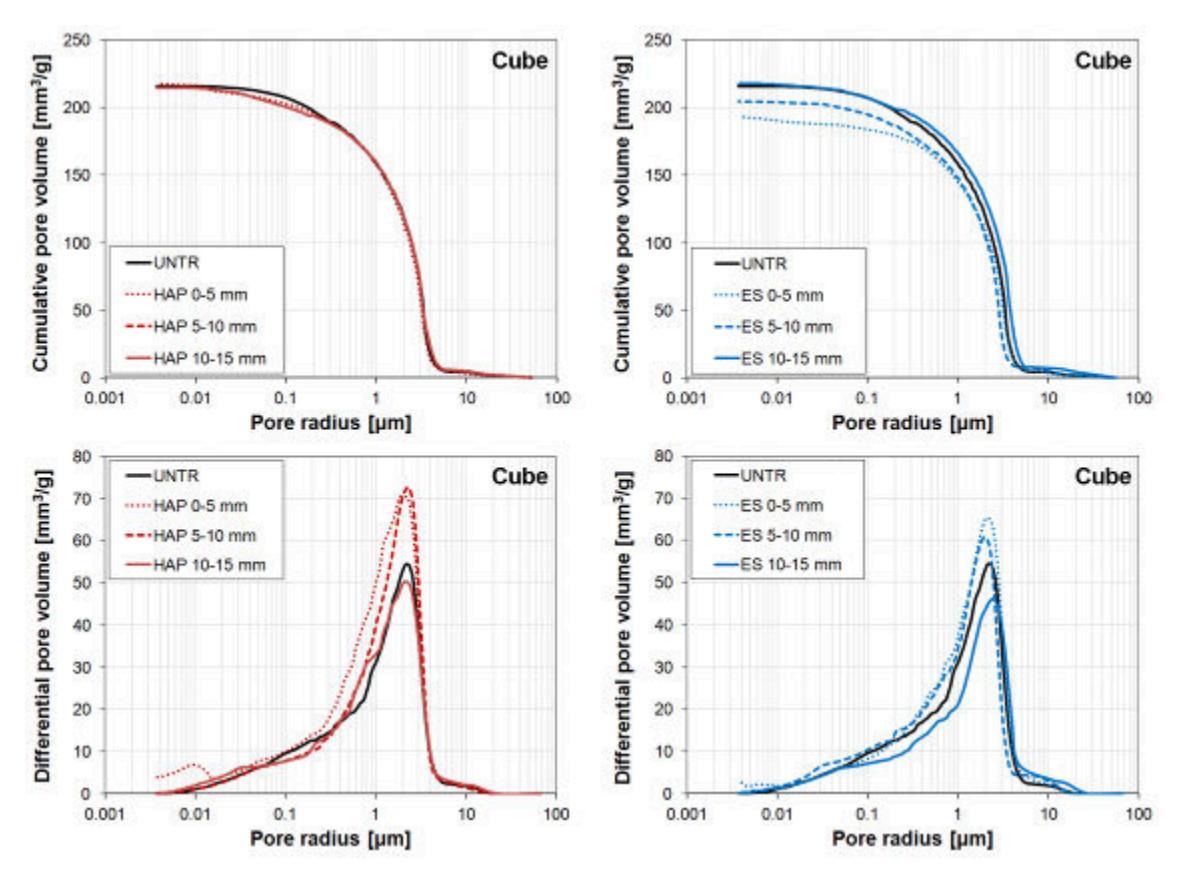
**Figure 4**. Pore size distribution of untreated and treated cubic samples (for each condition, three samples were analyzed, collected at a depth of 0-5, 5-10 and 10-15 mm from the treated surface).

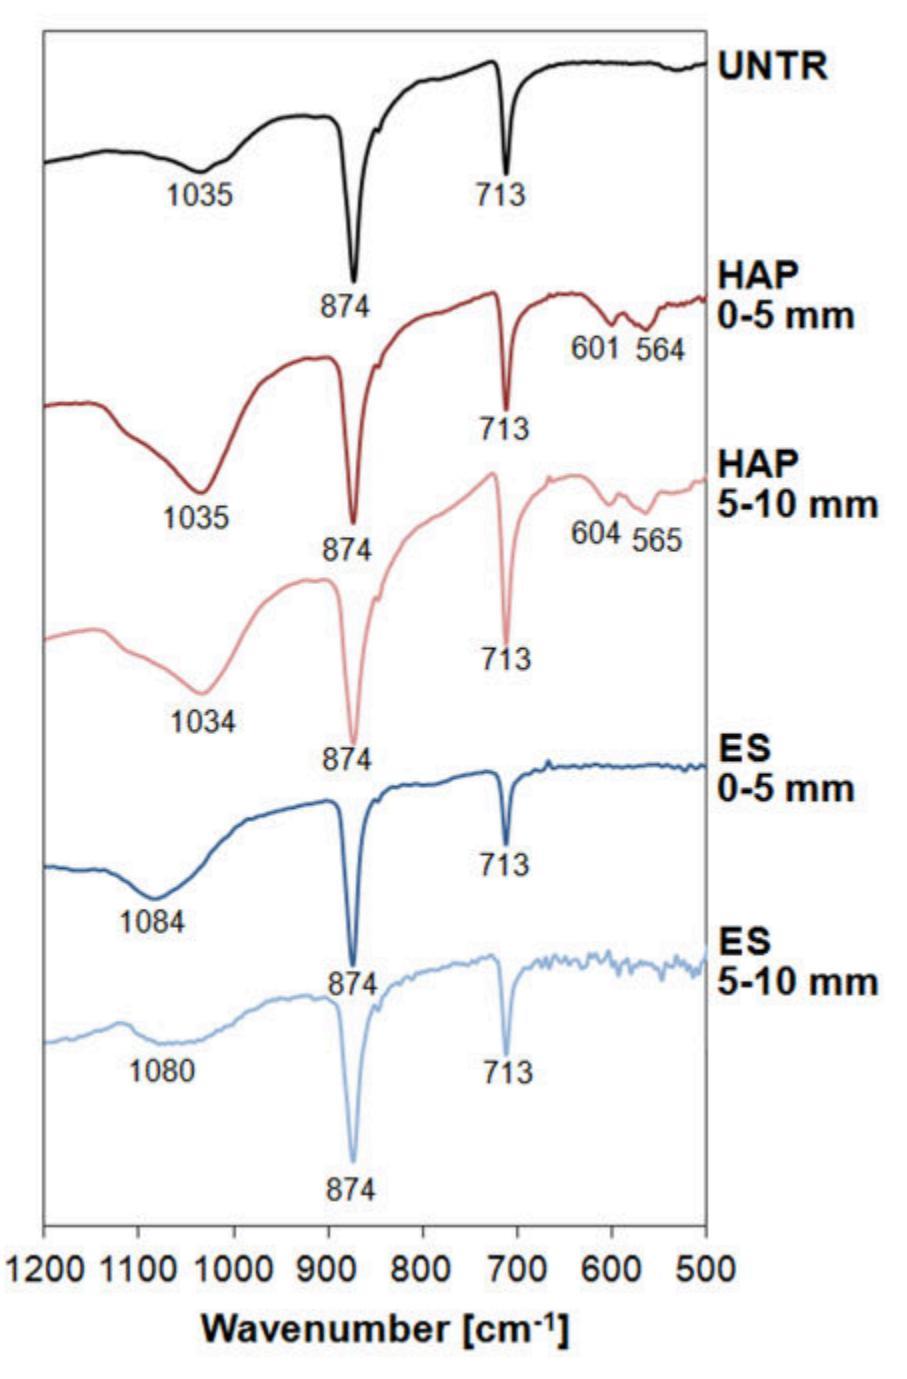
**Figure 5**. FT-IR of untreated and treated samples. For treated samples, two measurements were performed, at a depth of 0-5 mm and 5-10 mm from the treated surface.

<u>Newly formed phases and secondary by-products</u>. The DAP solution is expected to react with the substrate and lead to the formation of HAP and volatile ammonium carbonate, which is not corrosive to stone [18]. Accordingly, in the FT-IR spectra of DAP-treated samples (Figure 5) bands at 564-565 cm<sup>-1</sup> and 601-604 cm<sup>-1</sup> were detected, which are compatible with bands attributed in the literature to P-O bonds of HAP [61], while no ammonium carbonate, unreacted DAP or highly soluble metastable calcium phosphate phases were found. However, it should be noted that the

In the case of ES, hydrolysis-condensation reactions lead to the formation of silica gel and volatile ethanol as by-product, which is not corrosive to stone [16]. Accordingly, FT-IR spectra of ES-treated samples (Figure 5) showed a marked band at 1080 cm<sup>-1</sup>, owing to Si-O-Si groups of silica gel [66]. Moreover, a slight band at 1170 cm<sup>-1</sup> was also present, especially in the deeper sample, which can be attributed to Si-O-C groups of non-hydrolyzed ES [66], even after 1 month curing. From a chemical point of view, the formed silica gel could be regarded as similar and hence

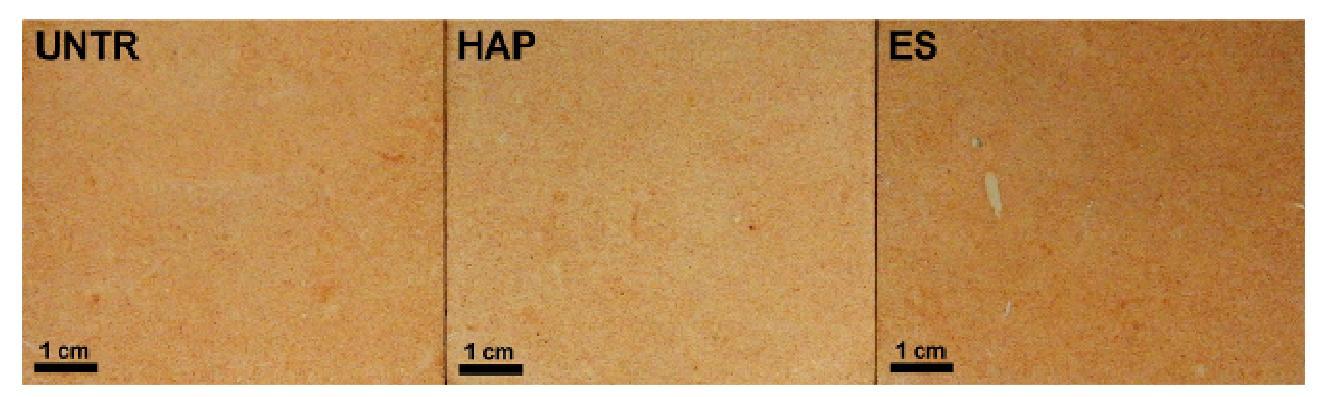
Figure 6. Color change after treatment.

<u>Colour change</u>. For HAP- and ES-treated samples, colour change is illustrated in Figure 6 for three exemplificative prismatic samples, while quantitative values are reported in Table 4. ES causes a very limited modification of colour parameters, while HAP is responsible for non-negligible alterations, mainly in terms of lightness ( $L^*$  parameter). Anyway, both treatments can be considered as acceptable, as they are below the threshold generally accepted for stone consolidants ( $\Delta E \leq 5$ )[21], even if in the case of HAP the corresponding colour change is visible by human eye ( $\Delta E > 3$ ) [23].

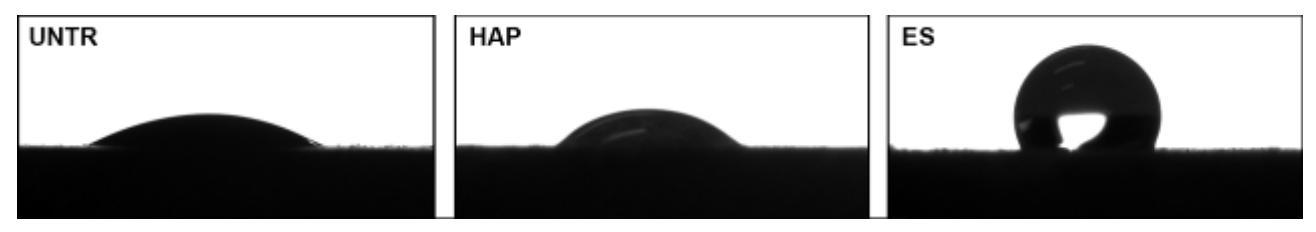
Figure 7. Contact angle of untreated and treated samples.

*Physical properties*. The effects of the two treatments on stone behaviour, in terms of contact angle ( $\alpha$ ) and time for water absorption ( $t_a$ ), are reported in Figure 7 and Table 6. HAP caused an increase of both parameters, but the contact angle of treated samples remained below the 90° conventional threshold between hydrophilic and hydrophobic behaviour. On the contrary, after consolidation with ES, treated stone definitely acquires a hydrophobic behaviour, as denoted by the contact angle (remarkably above the 90° threshold) and time for water absorption (largely increased with respect to the untreated reference). This hydrophobicity is caused by the presence of residual ethoxy groups (also detected by FT-IR analysis) that remain in the stone until hydrolysis-condensation reactions have completed, which may take as much as 6-7 months [16].

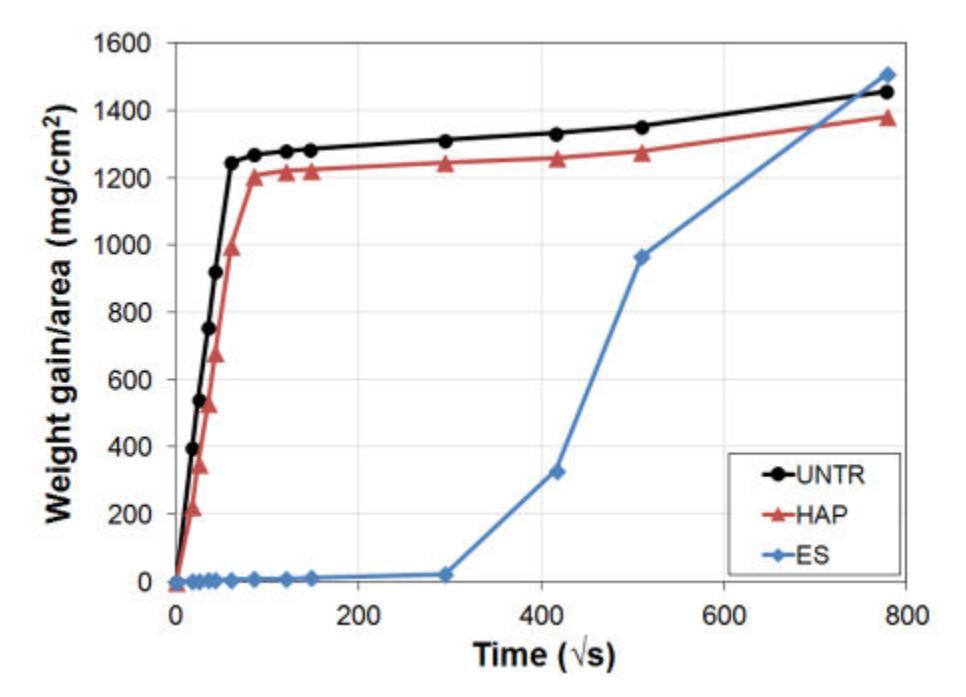
Figure 8. Water sorptivity of untreated and treated samples.

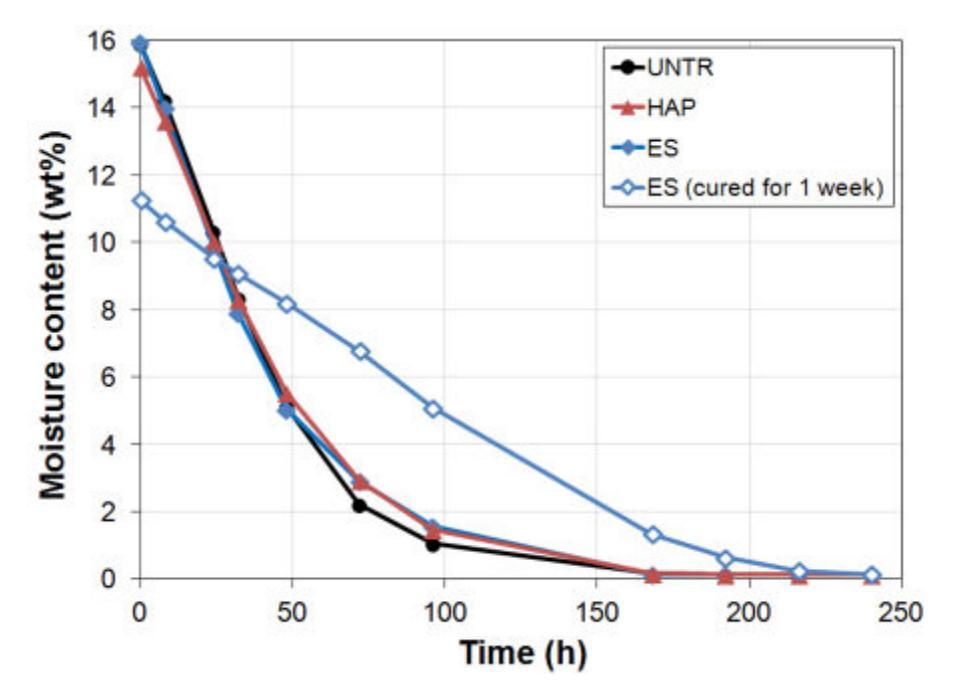
**Figure 9**. Drying rate of untreated and treated samples. For comparison's sake, a sample treated with ES and left to cure for only 1 week before the beginning of the test was also considered (for this sample, the initial moisture content is notably lower than for the other samples, as the ES-treated layer is still hydrophobic and so it cannot be saturated with water).

In terms of water vapour permeability, which should be not blocked after consolidation so that stone is allowed to "breathe" [7,19,30], both HAP and ES gave good results. As reported in Table 6, both treatments left the water vapour diffusion resistance coefficient substantially unaltered, in compliance with the requirement of maintaining water vapour permeability as high as possible [30]. It should be noted that the performance of ES-based treatments with respect to stone breathability may change significantly depending on the specific product used: according to literature, commercial ES-based products may cause decreases up to 40% [59]. Moreover, in the case of salt crystallization, stone breathability is not sufficient for preventing damage, as a high evaporation rate may even lead to high amounts of salts deposited inside the stone [16]. This further underlines the important fact that, after consolidation, stone ability to exchange *liquid* water with the environment must be preserved. This was investigated experimentally by measuring the drying behaviour of untreated and treated samples. As illustrated in Figure 9, both treatments caused very little changes to the stone drying rate, which can be regarded as a very positive feature. However, it should be noted that the behaviour of ES-treated stone changes significantly over time as curing proceeds. For instance, as illustrated in Figure 9 for a sample treated with ES left to cured for only 1

week before the beginning of the test, the drying rate is remarkably lower, compared to ES-treated sample cured for 1 months. This may cause durability issues before curing is completed and, therefore, the durability of ES-treated samples cured for only 1 week before weathering cycles was experimentally investigated in Part 2 [29].

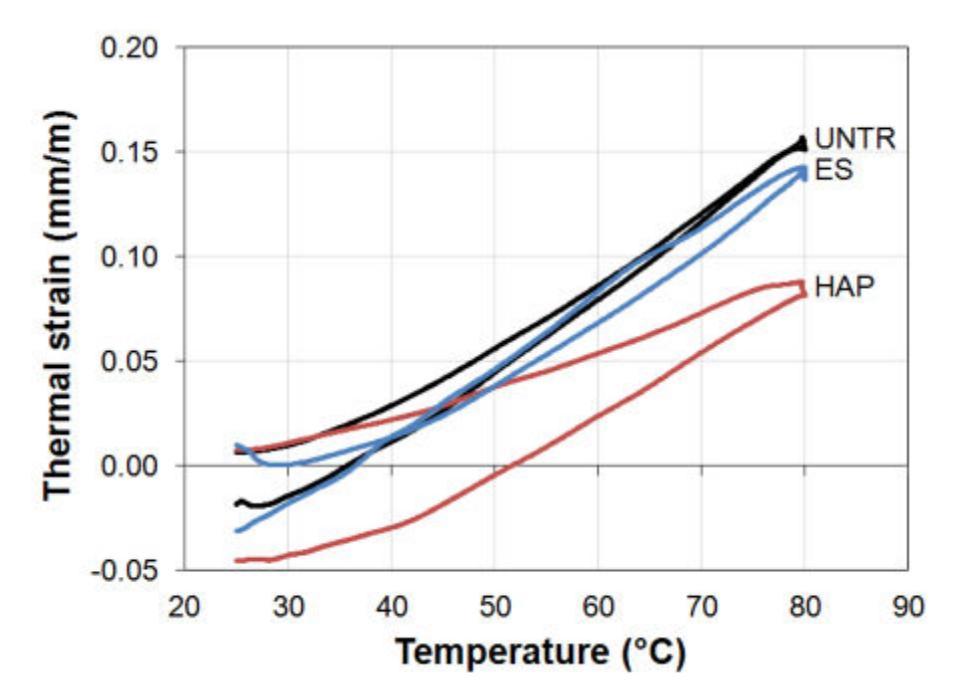
Figure 10. Thermal expansion of untreated and treated samples.
