MURAL PAINTING DIGITAL SURVEYS

Elena Murariu, private practice restorer, Bucharest, Romania
Florian Petrescu, GEOSYSTEMS Romania, Bucharest, Romania

4. APPLICATION: MONASTERY OF BISTRITA (BOLNITA)

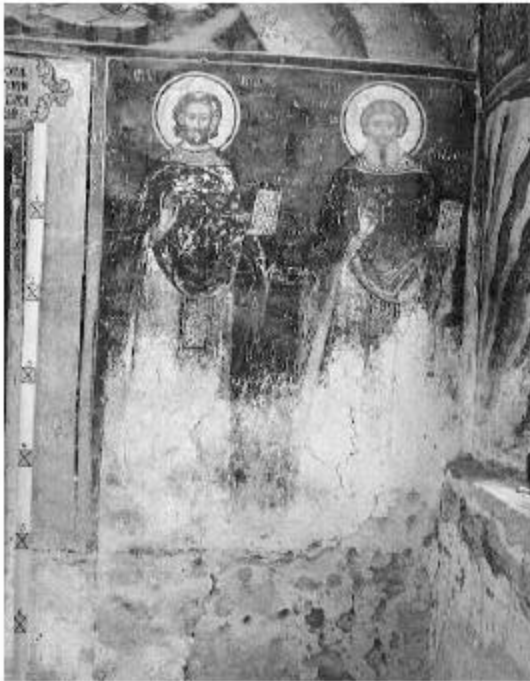
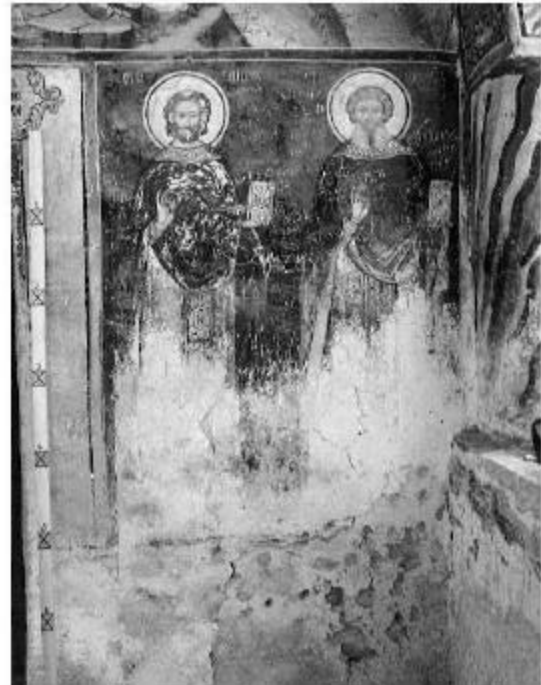
Figure 1. Scanned photograph (left) and geometrically rectified image (right)

The graphic reference basis (Figure 1) was created having scanned photographs as input. The scanning resolution was fixed at 400 dpi, according to the required centimetric accuracy.

For rectification purpose, the coordinate system was chosen such that mosaics and collages should be possible. Thus, for each chamber an appropriate coordinate system was established. Therefore, the entire church was naturally decomposed in altar, narthex, exonarthex and exterior.

Due to the emergency character of the project, the conservator decided that image rectification should be performed exclusively for those areas where typical deterioration phenomena are encountered. For all the other areas, a general outline of the walls was digitized.
